Assessment of Tod House, Oak Bay, BC

Executive Summary

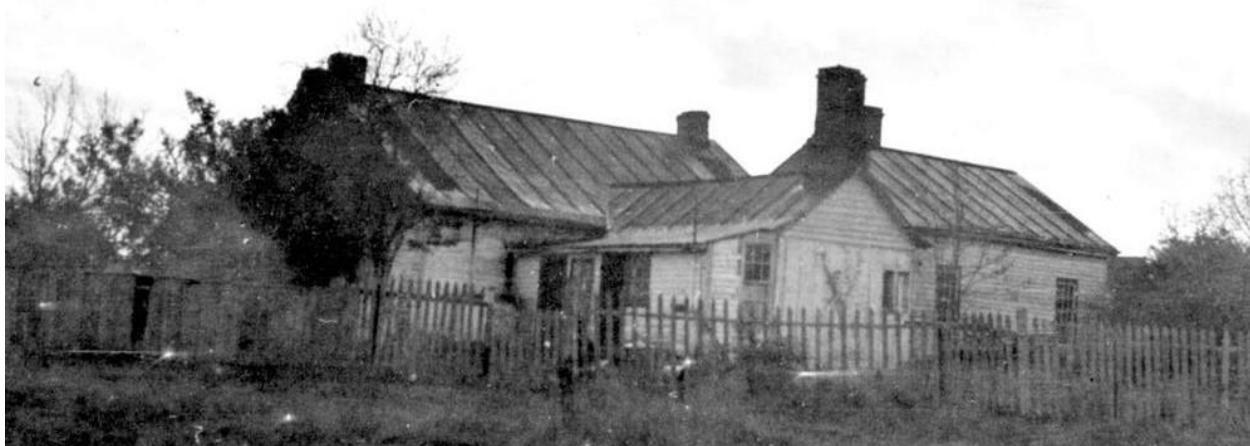
Figure 2 - The rear of Tod House in 1934. Note the tarpaper roofing laid over shakes. RBC Museum and Archive.

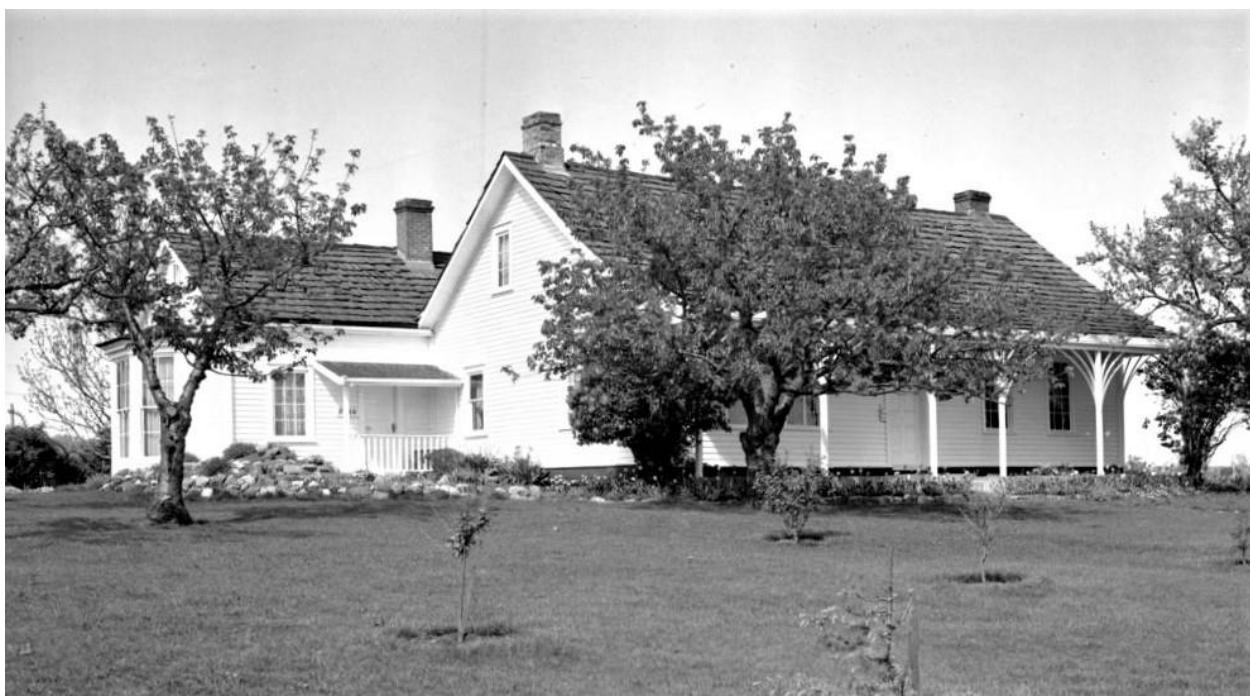
Figure 3 - Tod House circa 1953. Note the split shake roof and rear porch. NB this photo is misidentified in the RBC Archives as an image from 1934.

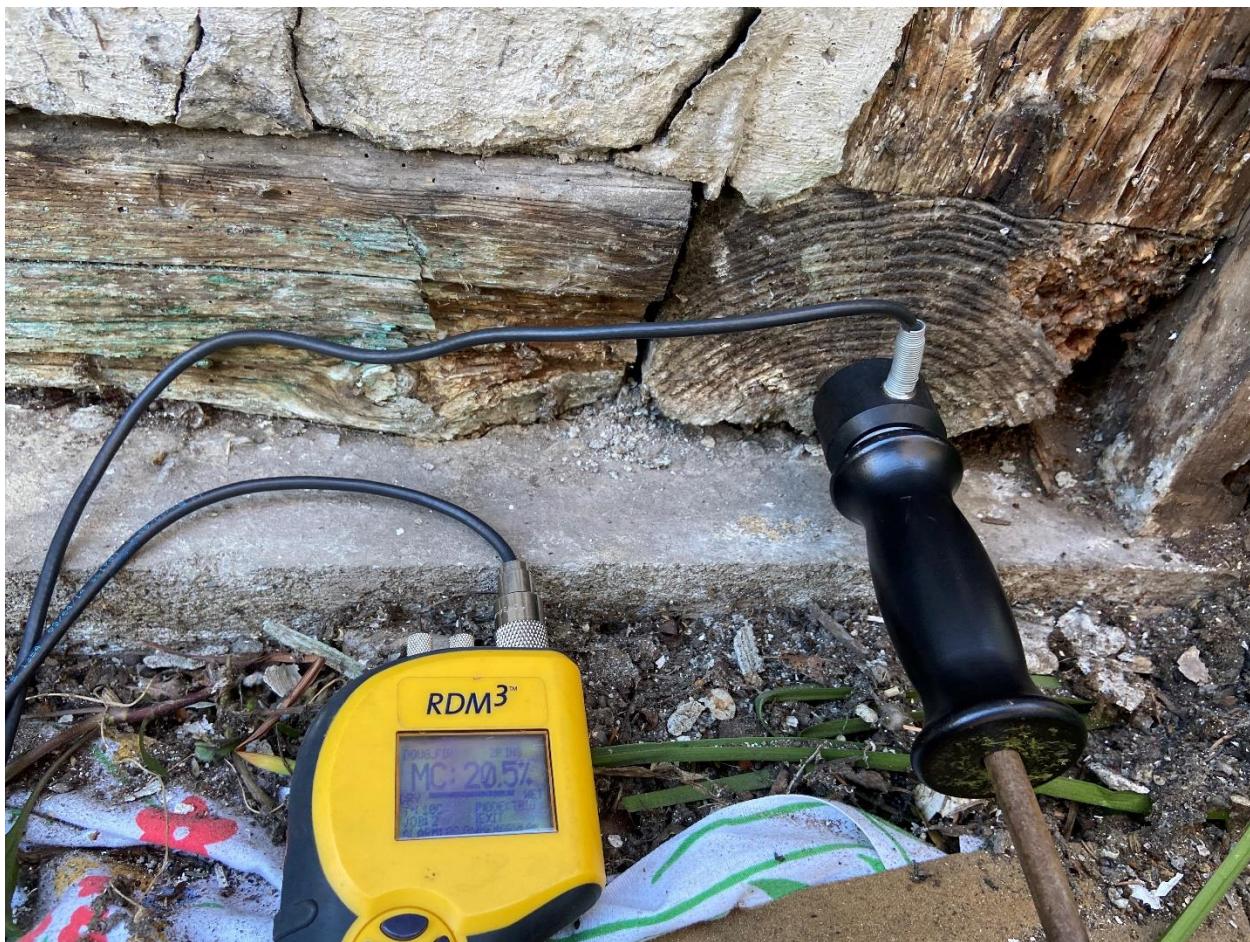
Figure 5 - Wet and rotting sill plates of the original timber structure are revealed during the removal of exterior siding and wall cladding below W6 in the oldest part of the building.

The foundations are generally in good condition. Much of the substructure (visible in the basement area) is modern, and while the house may have originally had a small cold storage area (e.g., root cellar), the current layout was likely made to accommodate a modern furnace and solid fuel storage. Unfortunately, the modern substructure includes concrete patios and porches that are harming the building. For example, there are some places where modern concrete foundations have been poured around historic timbers and these will now be rotten as a result.

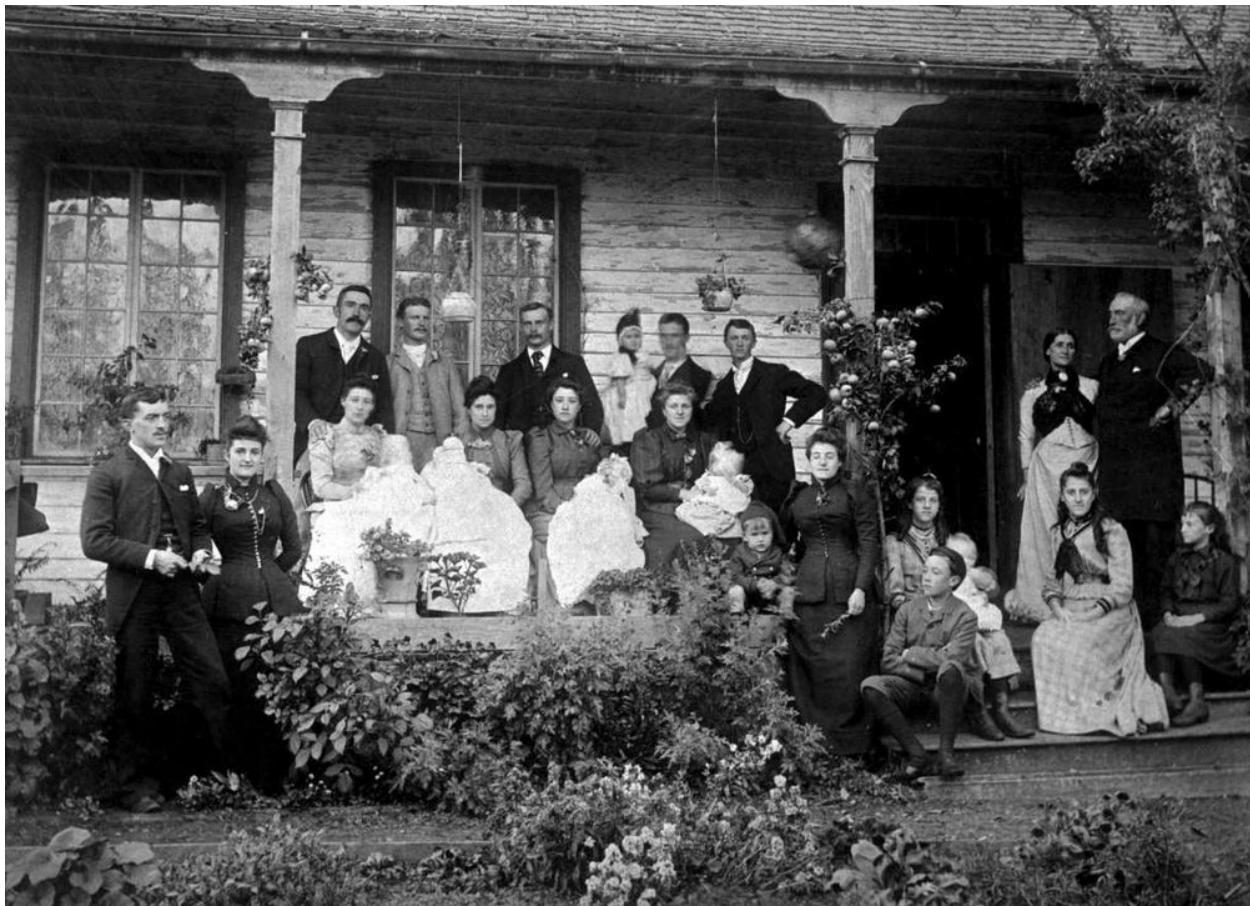
Figure 6 - Three generations of the Pauline family at Tod house in the 1890s. Note the wood posts and capitals, wood porch and steps, and plain transom light above the entrance door. J.K. Nesbitt collection. RBCM A-08840
