PREPARED FOR:	Committee of the Whole
FROM:	Ed Robertson, Director Engineering and Public Works and
	Pierce Mimura, Manager of Engineering, Infrastructure,
	Maintenance, Analysis & Planning
MEETING DATE:	May 21, 2024
SUBJECT:	State of the Infrastructure (Report 1 of 2)
MEETING DATE: SUBJECT:	Maintenance, Analysis & Planning May 21, 2024 State of the Infrastructure (Report 1 of 2)

<u>State of the Infrastructure Report (1 of 2)</u> PowerPoint State of the Infrastructure Report 1 of 2 State of the Infrastructure Report Report 1 of 2

District of Oak Bay May 2024

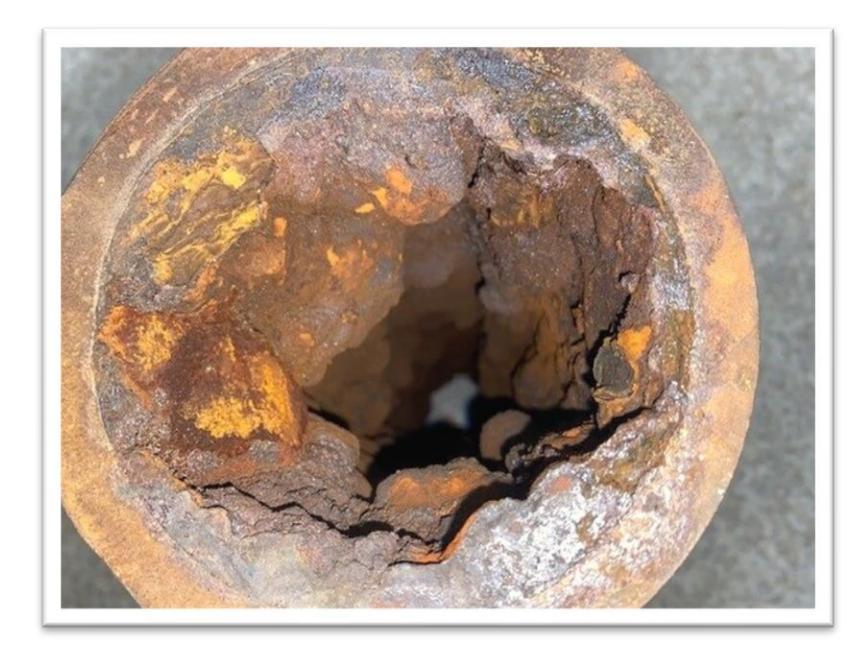
Photo 1: Tuberculation (rust) inside 150 mm (6") water main, evidence of reduced hydraulic capacity.

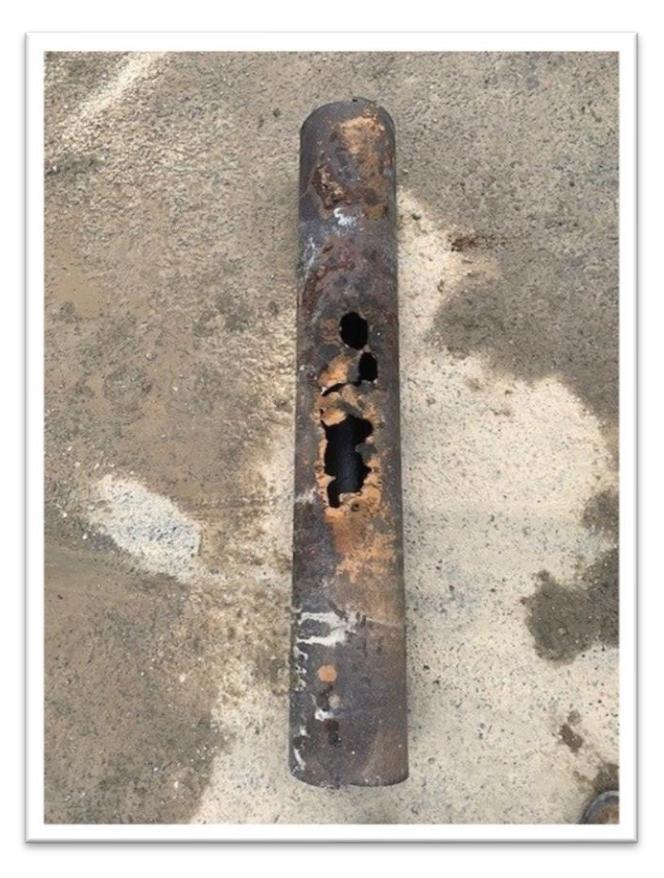
Photo 2: 1980's ductile iron main showing signs of severe corrosion, resulting in holes in the water main.

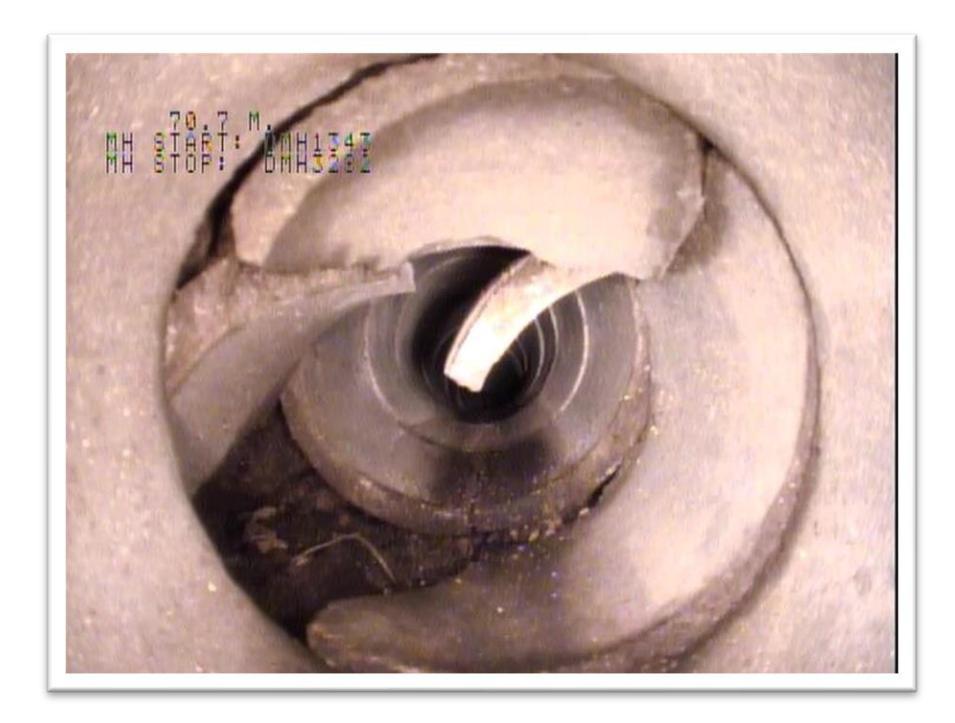
Photo 3: Broken main, evidence of severe fractures and circumferential cracking. Found in sanitary sewer and stormwater mains.

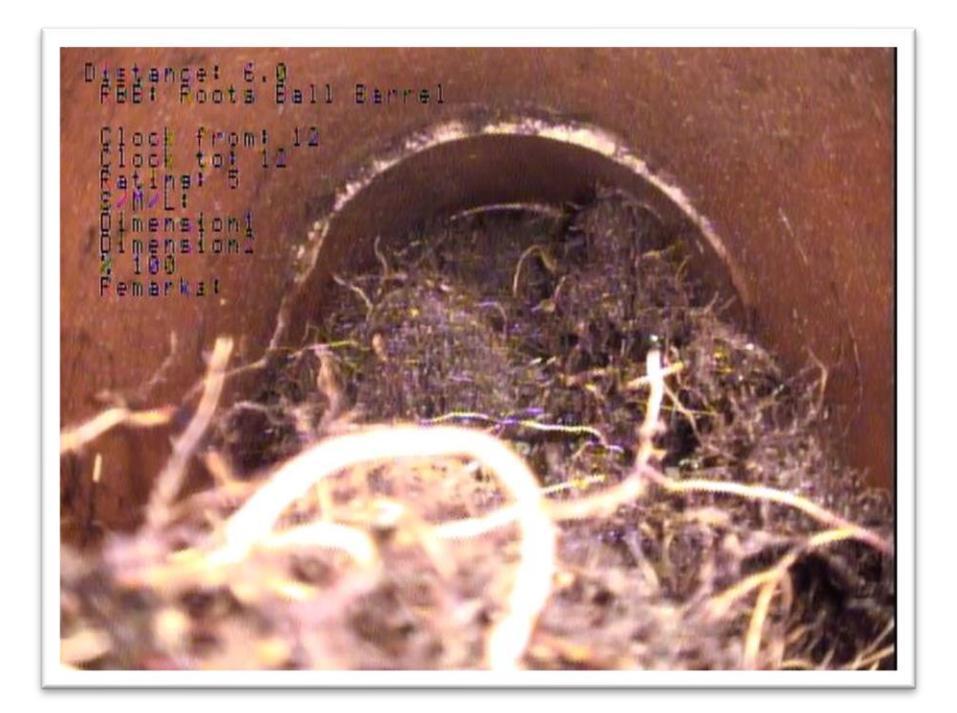
Photo 4: Root mass within the main that is creating a severe blockage. Roots can cause further cracking and reduce the overall structural integrity of the main. Found in sanitary sewer and stormwater mains.

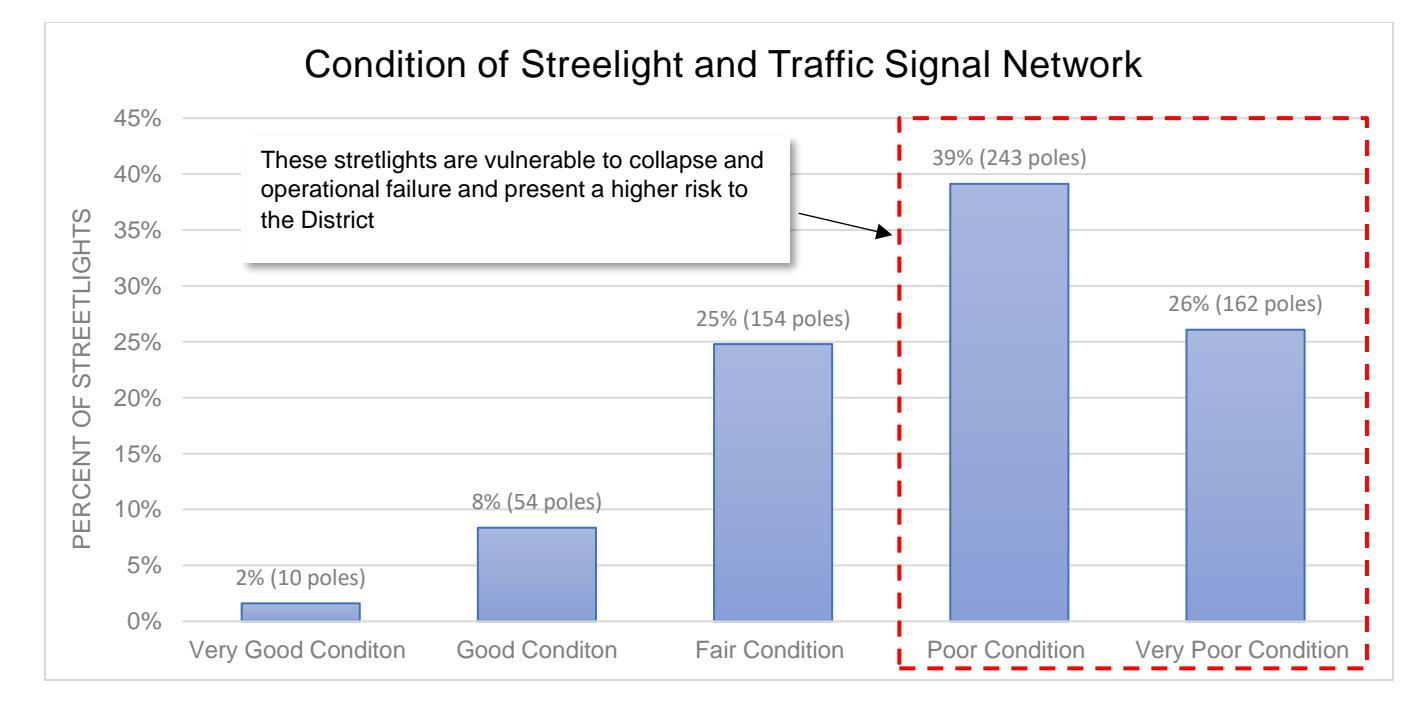
Figure 12: Condition Assessment Lighting Network

- 644 ornamental/decorative, davit, and traffic signal poles were assessed by reviewing the paint finish, surface rust, thickness, baseplates, damage, overall condition, anchor bolts, and concrete base location and type. 318 ornamental streetlights within the Uplands were out of scope of the study.
- Replace all very poor condition structures and repair and treat the poor condition structures as described in the Condition Assessment Report
- Based on the condition assessment, the condition of the streetlights are described in Figure 12.

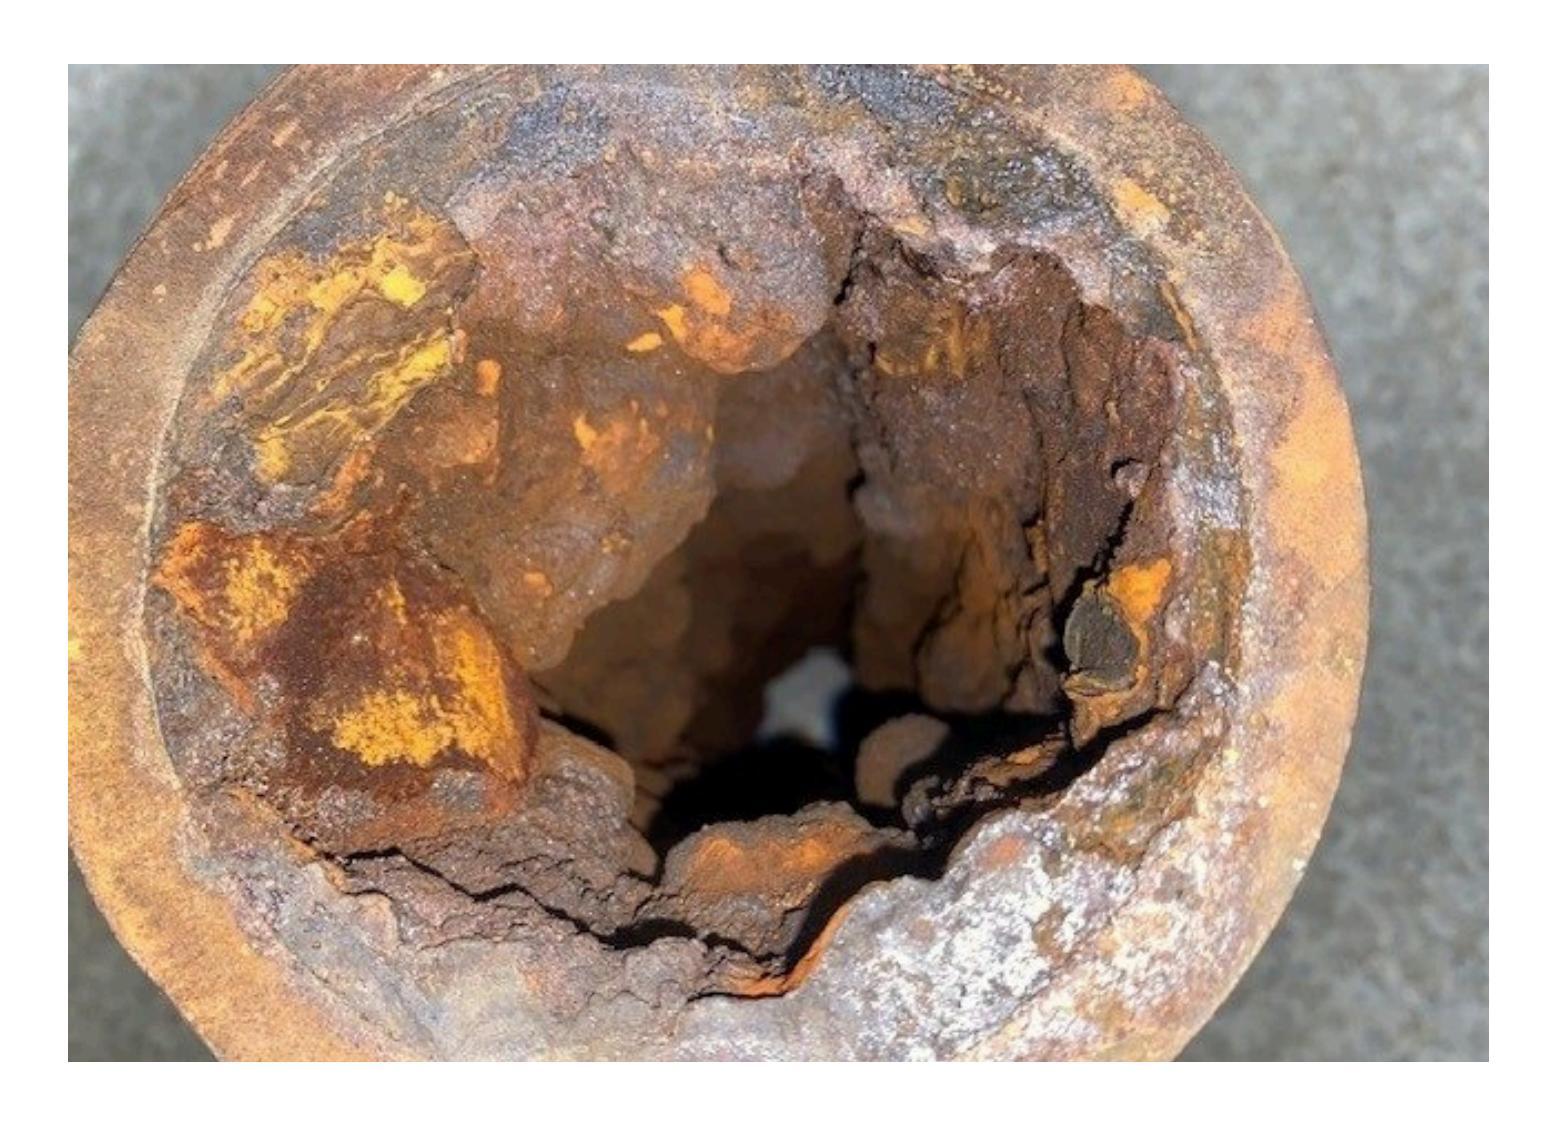
Tuberculation

- Rust inside of 150 mm (6") water main
- Reduces hydraulic capacity

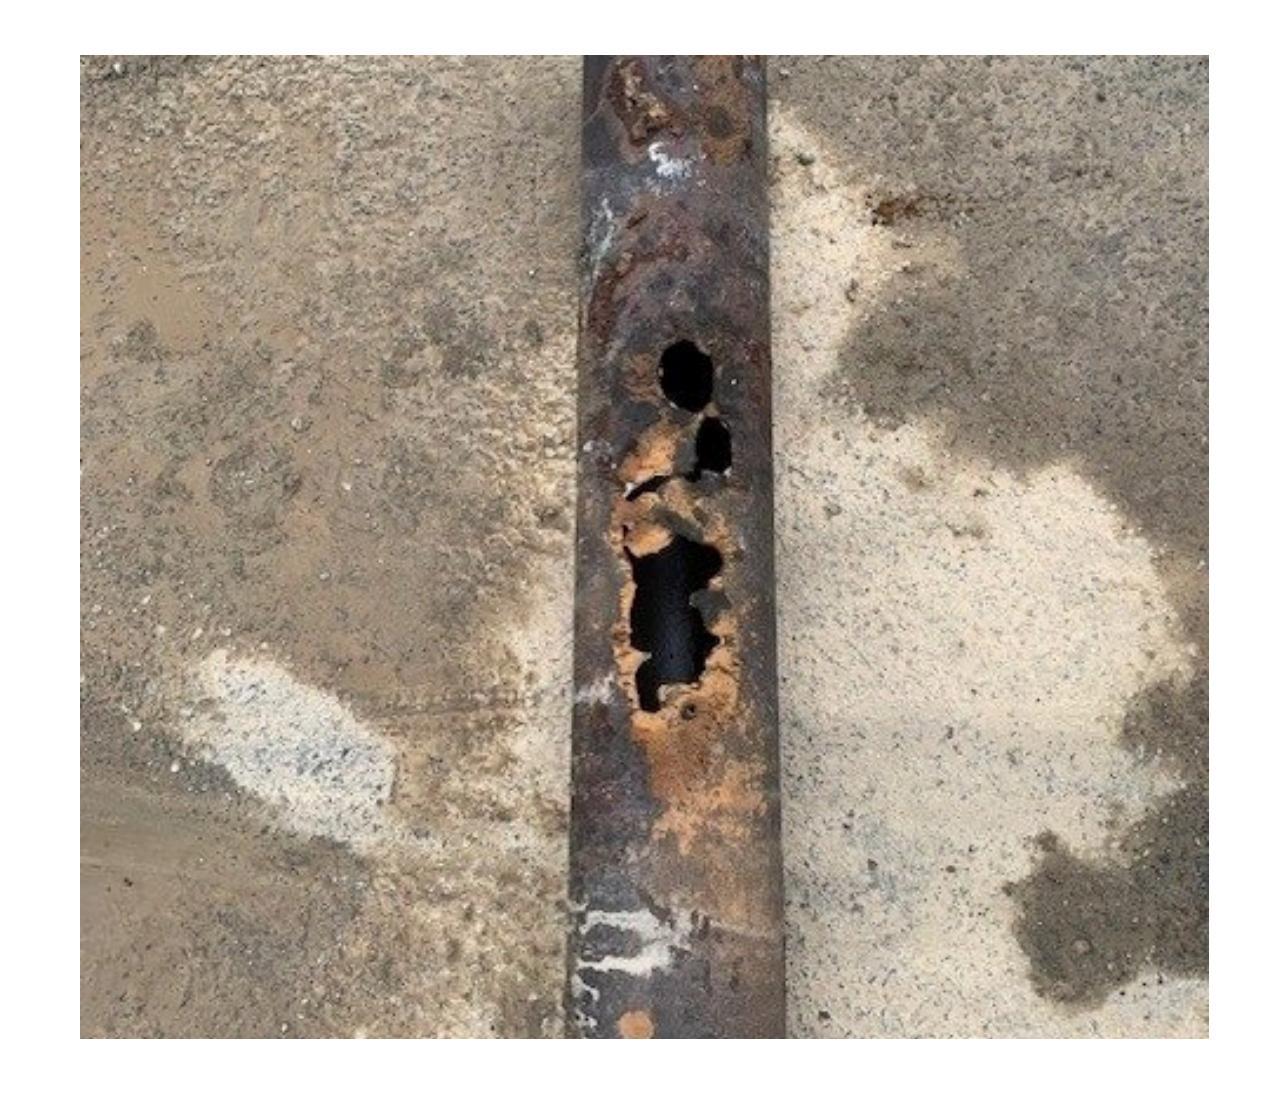
Corrosion

• Evidence of severe corrosion from 1980's ductile iron main • Holes/break in water main • Disruption in water service

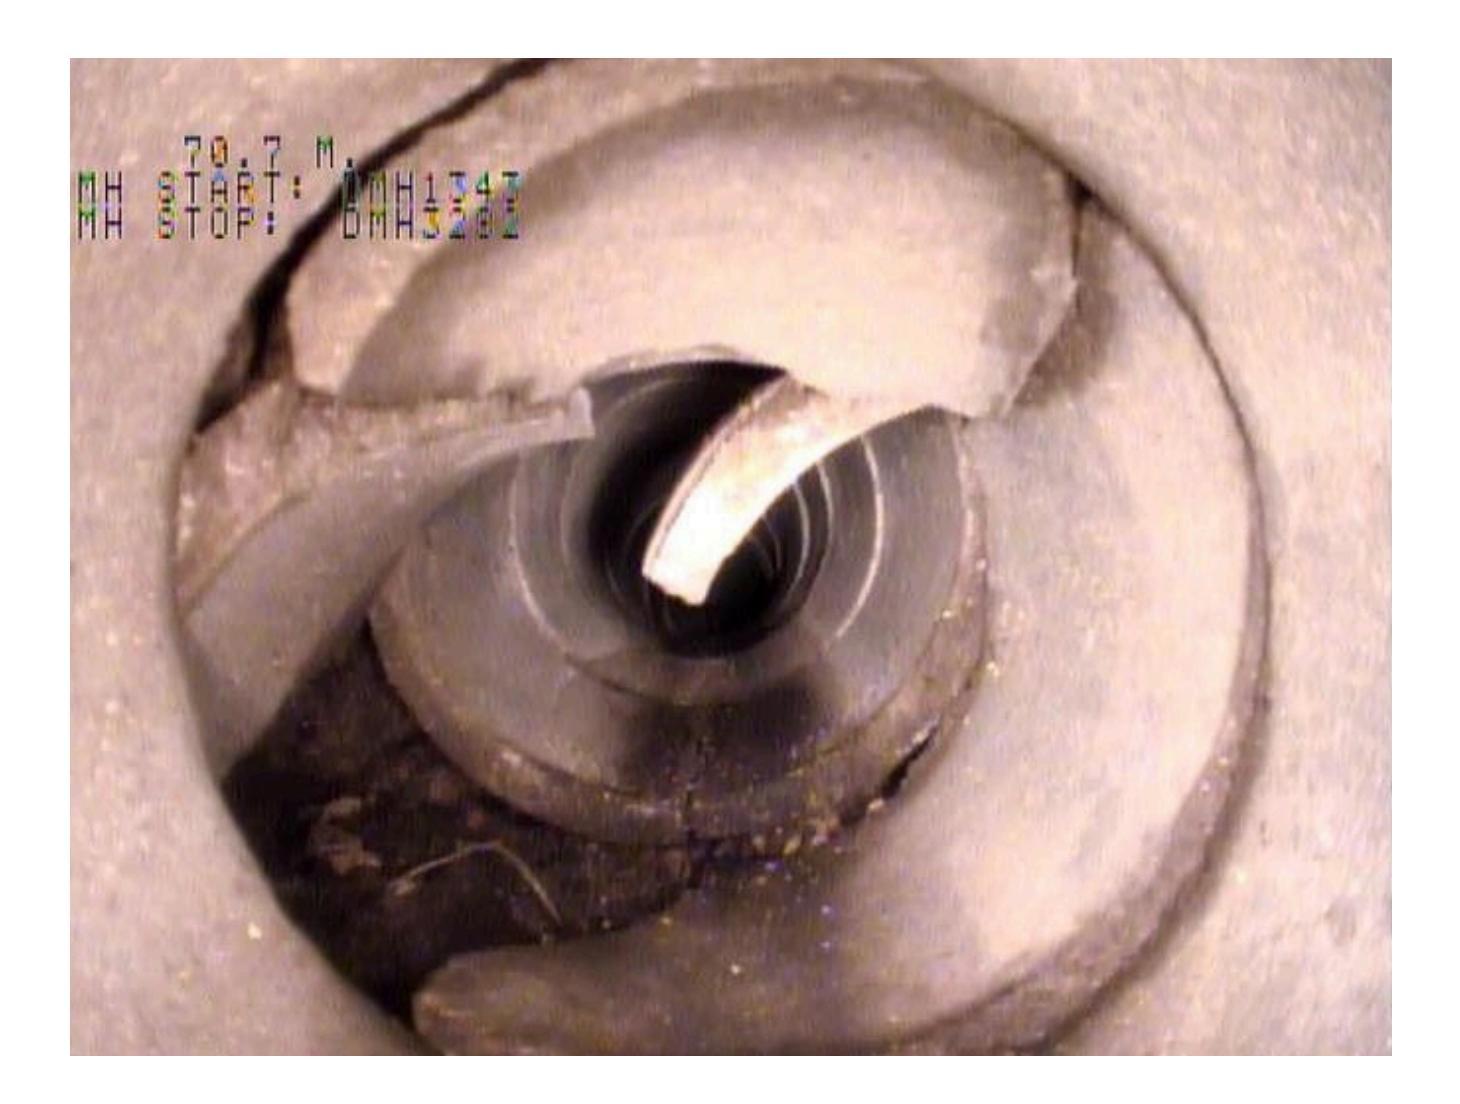
Fractures and Cracking

- Evidence of severe fracturing and displacement within mains
- Can collapse creating possible flooding or sewer backups

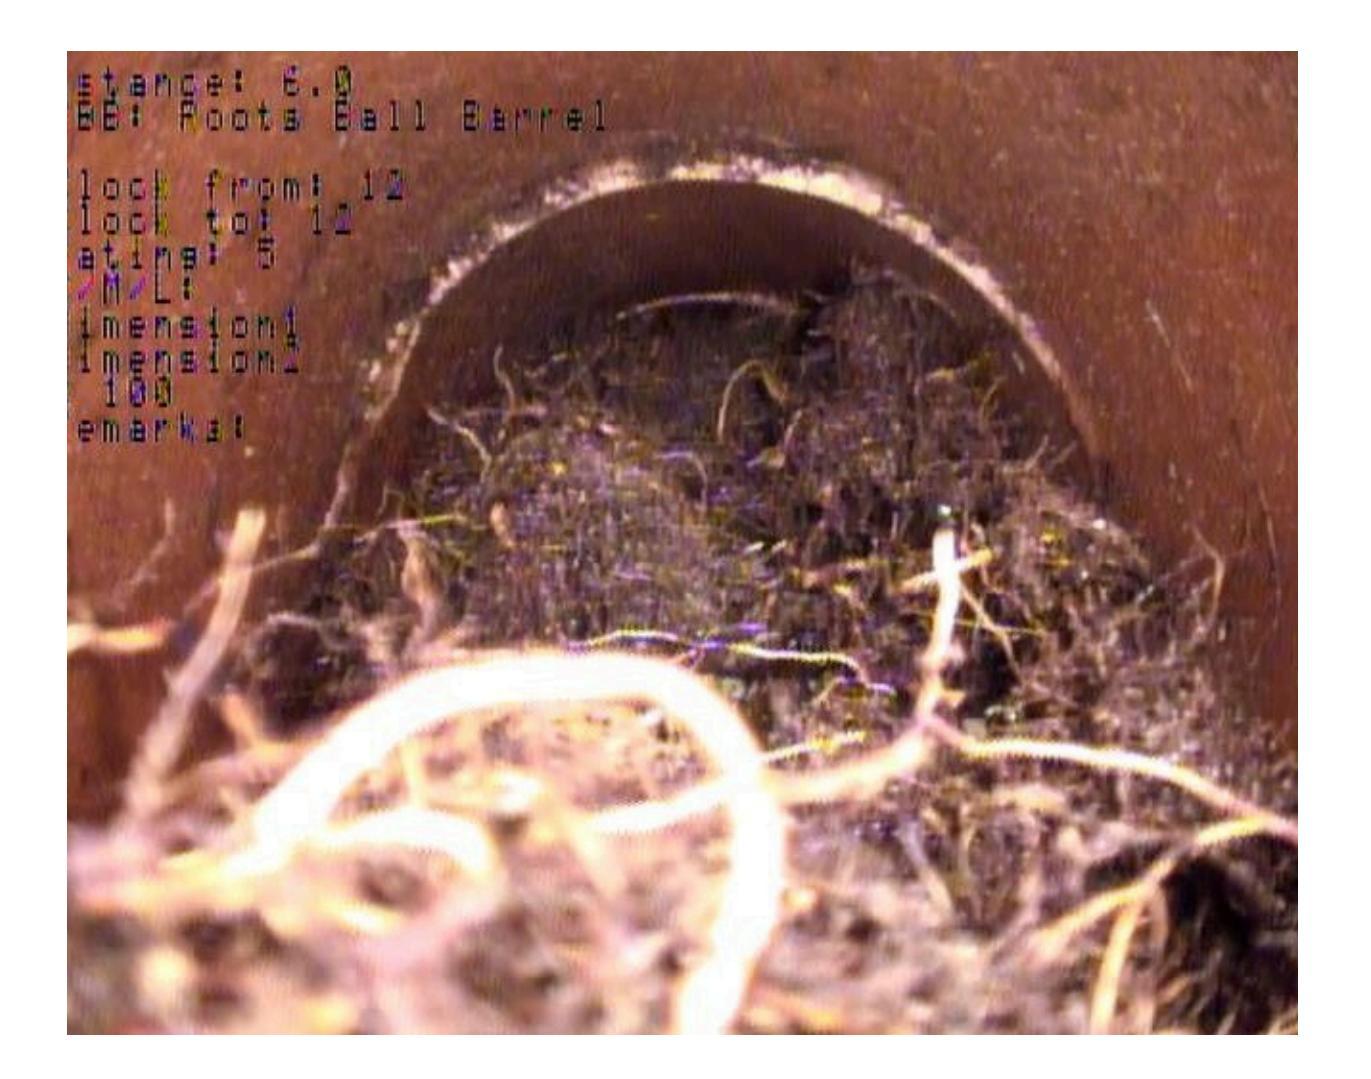
Root Intrusion

• Evidence of roots within the system • Causes blockage and further fractures • Can create flooding or sewer backups

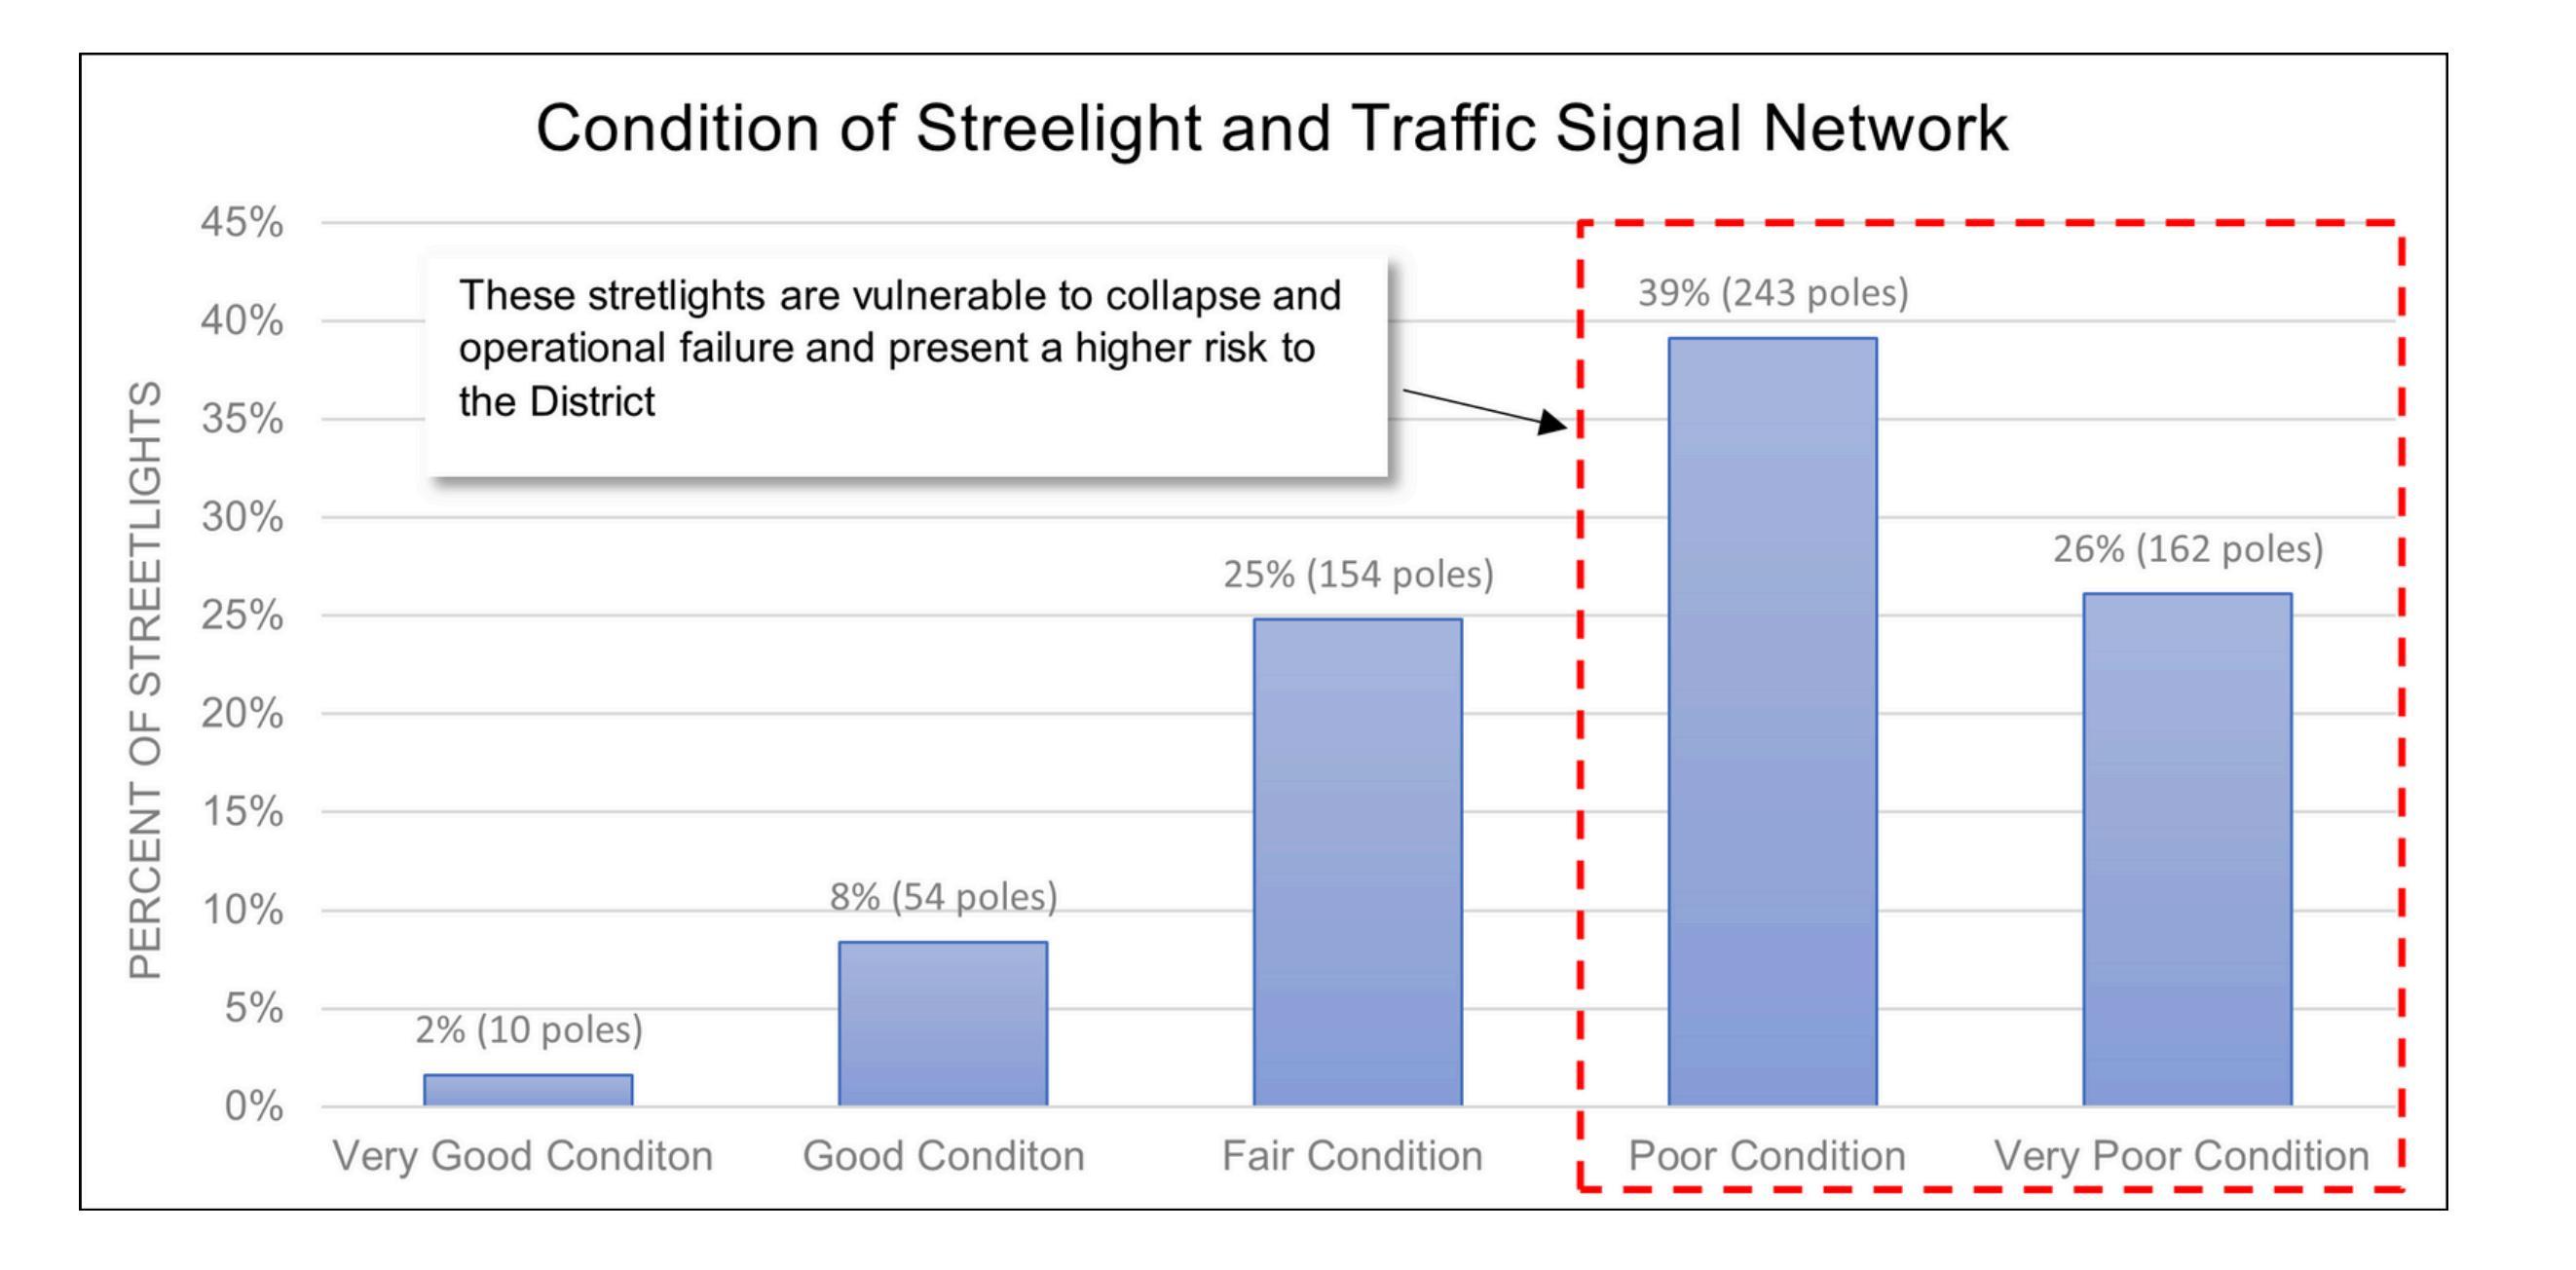
SURFACE INFRASTRUCTURE (STREETLIGHTING)

Very poor and poor condition poles creates a risk to public safety and property
ENGINEERING STANDARDS, SPECIFICATIONS, AND BEST PRACTICES
