**1587 York Place/1562 Prospect  
Place Heritage Revitalization Agreement Authorization Bylaw  
No. 4885, 2025**

A Bylaw to authorize a Heritage Revitalization Agreement for 1587 York Place and 1562 Prospect Place.

**HERITAGE REVITALIZATION AMENDMENT AGREEMENT**

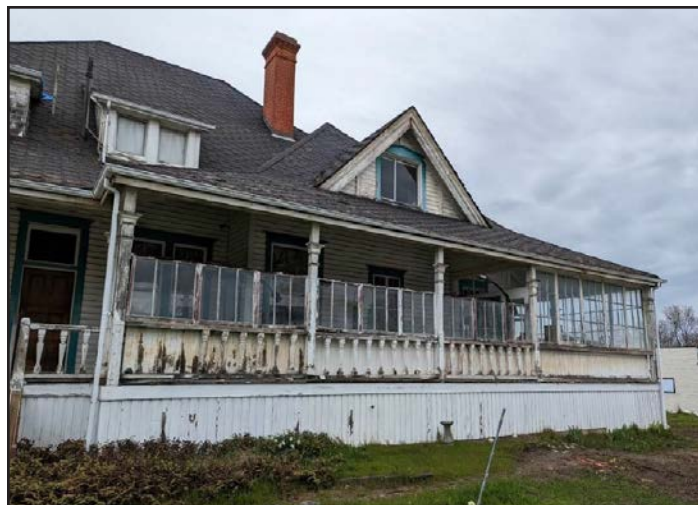
Fig. 36a: View of 1587 York Place, May 2023. (Source: Bellant)

Overall, the exterior of Annandale at 1587 York Place appears to be in fair to poor condition. Cummer Heritage Consulting (CHC) conducted a site review of the property in January 2023, with a follow-up in September 2024, and Herold Engineering Limited (HEL) conducted a Visual Building Condition Assessment in May 2023. Their conclusions and recommendations highlighted the following (Figs. 36). Please note that all of these assessments involved an exterior visual review of the property only; no testing or material samples were taken.

Deferred maintenance is taking its toll on the building. In the course of our visual condition assessment HEL identified a number of areas of concern with the fabric of the building

- The Asphalt roof shingles and flashings are life expired and require immediate replacement to control the on-going water leakage into the structure.
- Exterior cladding, fascias and trims are in poor decorative order, targeted repairs to rehabilitate and conserve the exterior of the building are strongly recommended.
- The veranda enclosure secondary glazing and guardrails are in poor condition and now present a life safety risk.
- Inadequate connectivity of framing members at the crawlspace and foundation level pose a risk to the overall seismic performance of the building.
- There is a high likelihood that there is concealed deterioration to structural members due to on-going water leakage from the roof.
- Significant sloping of upper level floors and cracking of finishes suggests that differential foundation movement may have occurred.

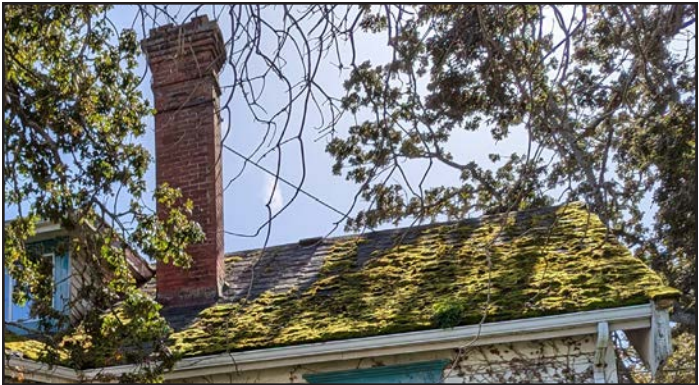
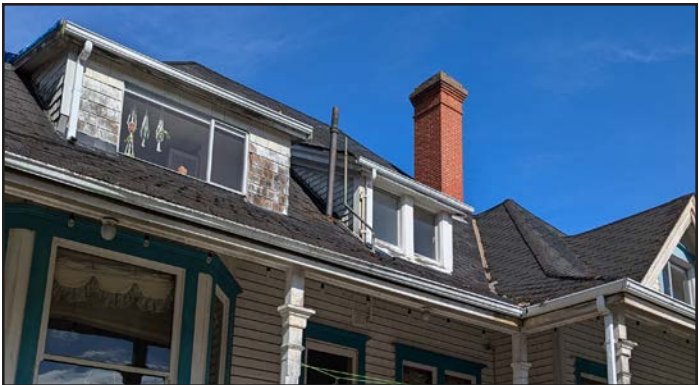
It is unclear exactly how old the current roof is, however, its condition overall is fair to poor with curling and decaying shingles and missing flashing in places as well. “The roofing shingles are in poor condition and life expired” (HEL 2023, p. 3). Various skylights were installed in the roof, over time. “The skylights are not operable and are in fair condition” (HEL 2023, p. 10). There is also abundant moss growth on the roof, particularly on its rear end (Figs. 37 to 38). Roof replacement is highly encouraged.

It is difficult to determine the full condition of the drainage system from a simple exterior inspection, however, the current gutters are falling off in places. As part of this conservation work, the drainage system (including the elements below ground) should be upgraded to guarantee optimal performance, with a regular maintenance schedule put in place to ensure their continued efficient and effective functioning.

Figs. 37 and 38: (Top) Northwest corner roof, 2024, showing deterioration and excessive moss growth. (Bottom) South facing roof, 2023, showing the deteriorating roof, in particular the missing flashing. (Sources: Cummer)

- The roofing and drainage will be **rehabilitated** with a new roof and drainage system being installed.
- These should be regularly monitored and maintained to ensure their ongoing good condition.

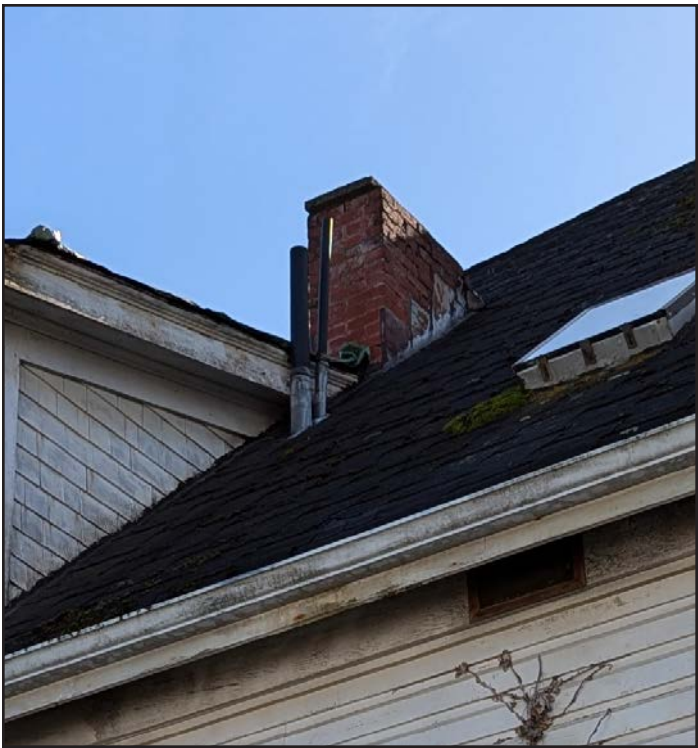
There are four chimneys on the house in varying condition. Three of the four are, for the most part, in good to fair condition (see Figs. 37 and 38 above). There are concerns with them in the event of an earthquake: “Without additional structural supports it is likely that the chimneys would perform poorly during a seismic event” (HEL 2023, p. 4). The northeast chimney is in very poor condition with much of it missing (Fig. 39).

Fig. 39: Northeast corner of Annandale, 2024, showing the chimney remnant missing its top half. (Source: Cummer)

- The intact front chimney will be **restored**, following relocation, with its form and detailing being **preserved**.
- The second front chimney, the chimney remnant will also be **restored**, using salvaged bricks from the chimneys of the rear wing, following the form and detailing visible in the historical photographs of the house.

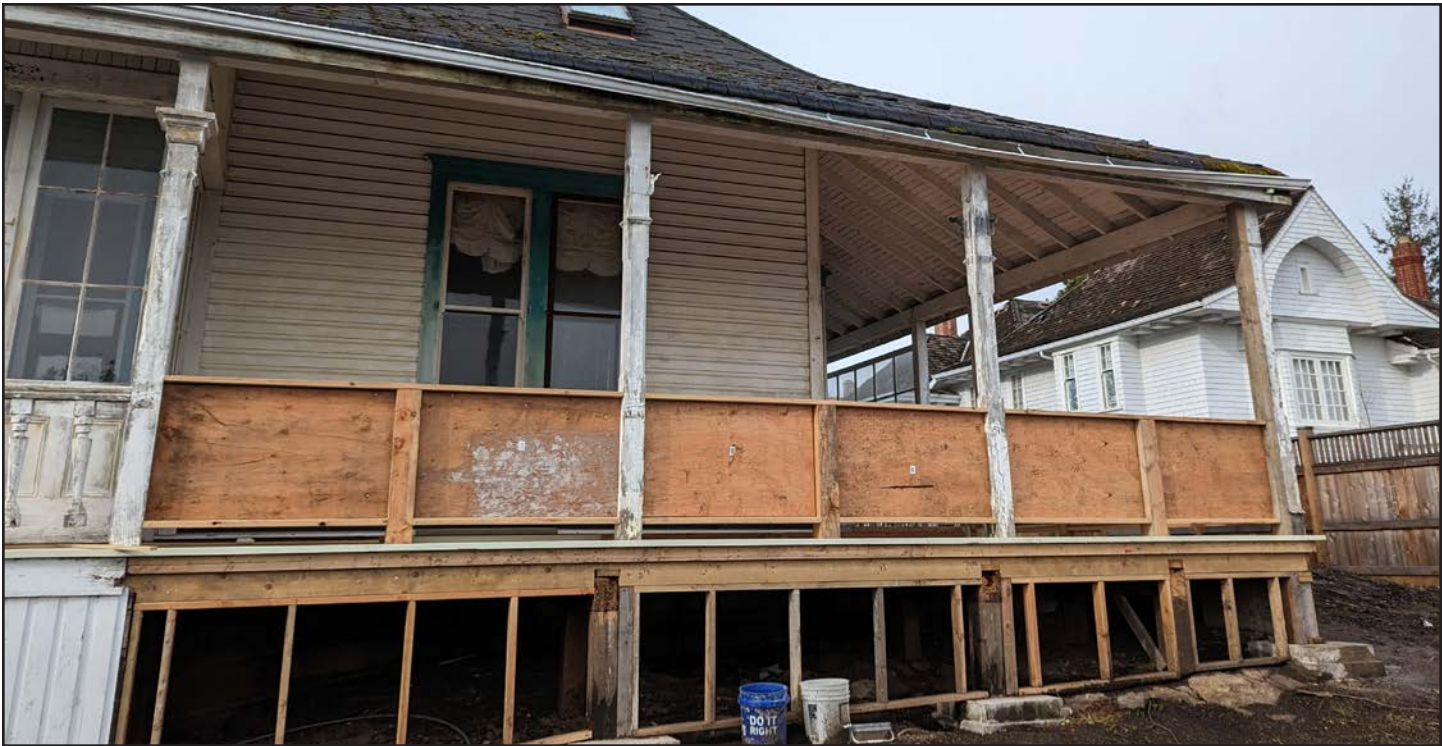
The verandah needs attention. There are rotted support beams; “this condition is structurally inadequate” (HEL 2023, p. 13). Sections have been temporarily stabilised, but the work appears incomplete (Fig. 40). “The glazing support rails are in an advanced state of decay and the support of the secondary glazing is clearly compromised” (HEL 2023, p. 11). Detailing, particularly the numerous balusters, have fallen off. There are balusters still on site, which could be used to restore this element.

Fig. 40: Northeast corner view of Annandale, 2023, showing the rotten beams and the temporarily stabilised portion of the verandah. Note the deteriorating roof and drainage system, with the gutter peeling away from the building. (Source: Cumber)

- The verandah should be **preserved**, but it needs extensive **restoration** work to improve its look and safety.
- The verandah’s enclosure will be removed, **restoring** it back to an open verandah, as described in 1897.
- Any elements that are in need of repair and **rehabilitation**, should use the materials available on site, where possible, or be **replaced in-kind**.

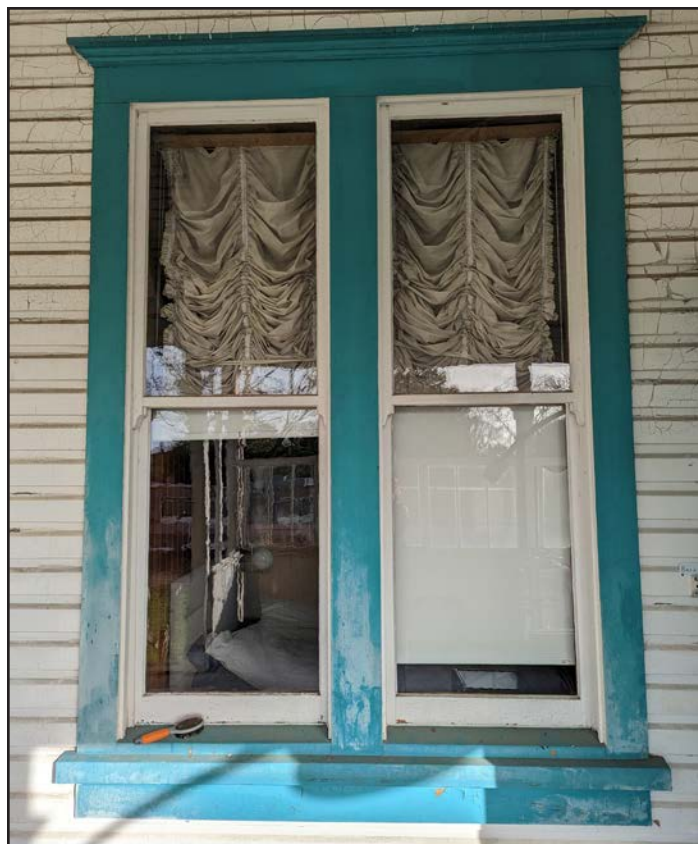
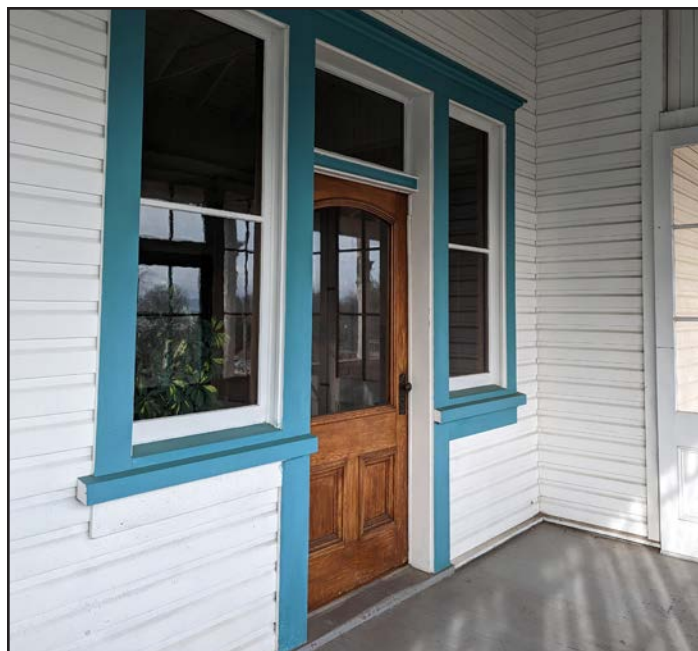
On each elevation, some of the windows have been replaced (especially on the rear end), however, some are still original, predominately double-hung horned wood windows (Fig. 41). Overall, considering the age of the building, the original, intact windows are in largely good condition. The original front door also appears to be in good condition (Fig. 42), spared from the elements over the years by the enclosed verandah.

Figs. 41 to 42: (Top) Example of the numerous surviving original double-hung horned wood windows, 2023, in largely good condition. (Bottom) Original front door of Annandale, 2023, also in good condition. (Sources: Cummer)

- All remaining original wood windows should be **preserved**, if and where possible. If any trims and/or sills need repair or replacement, these should be **replaced in-kind**. The surviving original dormer on the rear wing will be conserved and repurposed on the main structure to replace a mid-century skylight.

- The current front door should be **preserved** and **restored** with new staining.

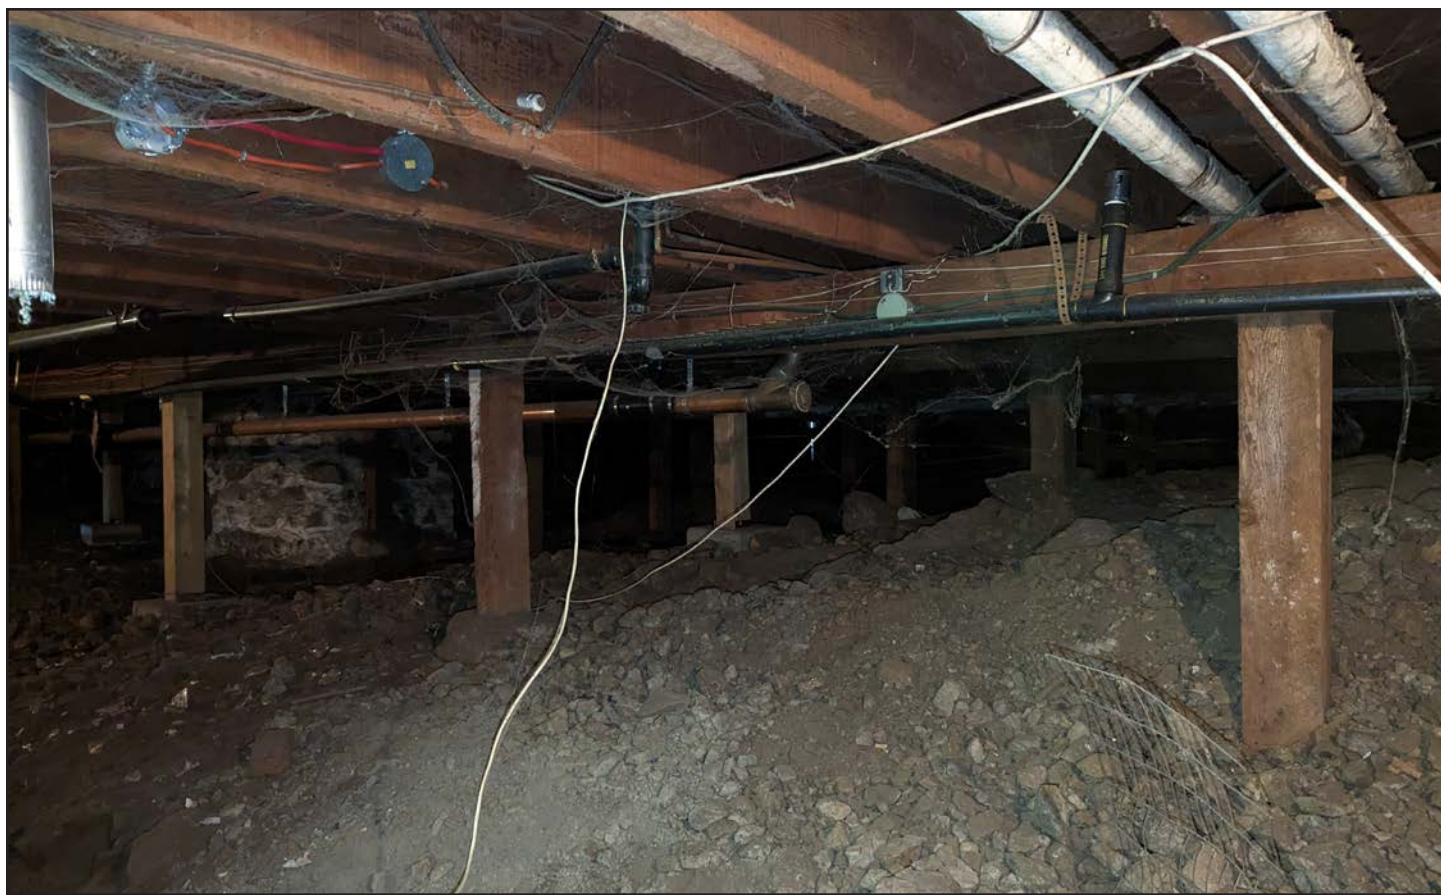
Fig. 43: View underneath Annandale, 2023. (Source: Cummer)

Overall, the condition of the walls and building envelope of Annandale, from roof to foundation, appear to be stable. However, a new foundation and additional supports are desirable to extend the physical life of the building, particularly considering how the house currently sits (Fig. 43). "Only nominal connections were observed between post and beam members and between post members and foundations. This connectivity deficiency could contribute to poor structural performance in a seismic event" (HEL 2023, p. 16).

- The main one and a half storey structure will be **preserved**.
- The structure will be **rehabilitated** by being put on a new foundation to extend its physical life and increase its structural stability, particularly in a seismic event.

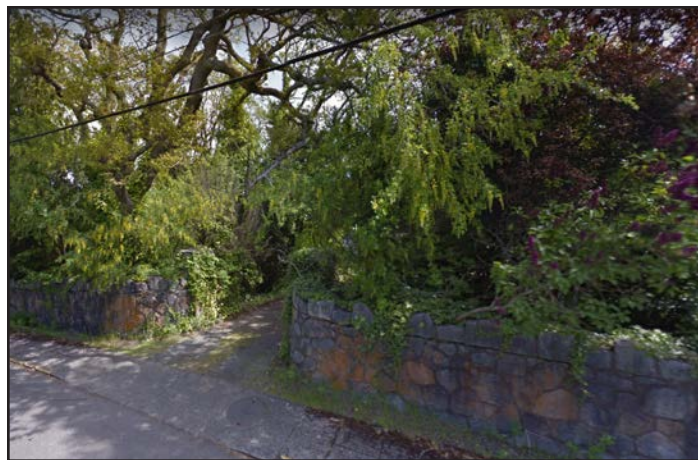
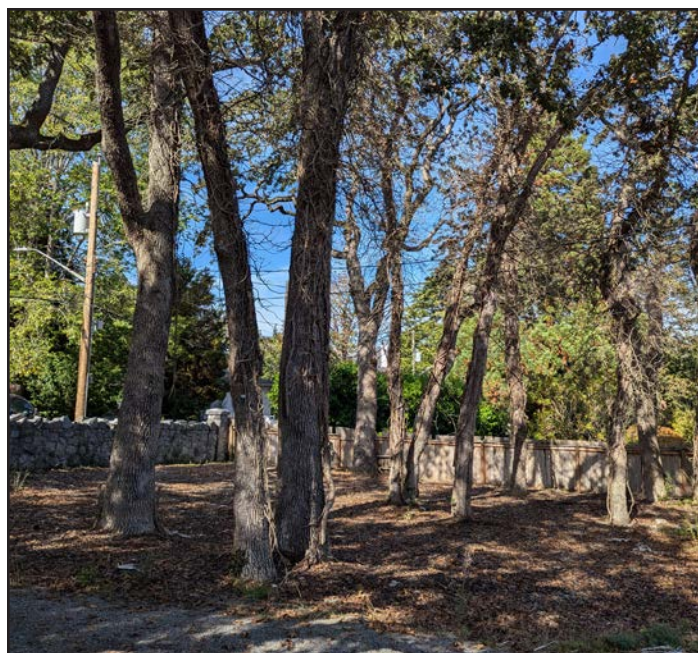
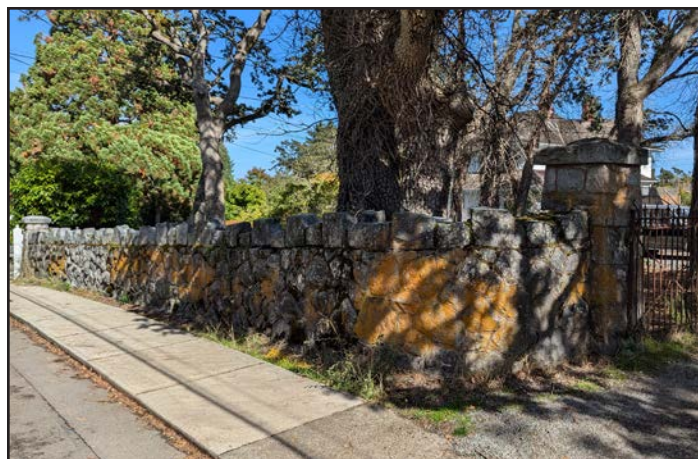
The landscaping on site is fairly minimal at this point, with much of the overgrowth having been removed (Fig. 47). A number of large trees (including Garry Oaks) are visible and present on site (Fig. 48). As mentioned, the western end of the house does have vines growing on it, which should be discouraged. The stone wall, along York Place, is in fair condition, in need of cleaning and maintenance (Fig. 49).

Figs. 47 to 49: (Top) Former landscaping on site, 2014. (Middle) View of some of the large trees on site, 2024. (Bottom) View of the York Place wall, 2024. (Sources: Google Street View and Cummer)
