PREPARED FOR:	Committee of the Whole
FROM:	Ed Robertson, Director Engineering and Public Works and
	Pierce Mimura, Manager of Engineering, Infrastructure,
	Maintenance, Analysis & Planning
MEETING DATE:	May 21, 2024
SUBJECT:	State of the Infrastructure (Report 1 of 2)
MEETING DATE: SUBJECT:	Maintenance, Analysis & Planning May 21, 2024 State of the Infrastructure (Report 1 of 2)

<u>State of the Infrastructure Report (1 of 2)</u> PowerPoint State of the Infrastructure Report 1 of 2 State of the Infrastructure Report Report 1 of 2

District of Oak Bay May 2024

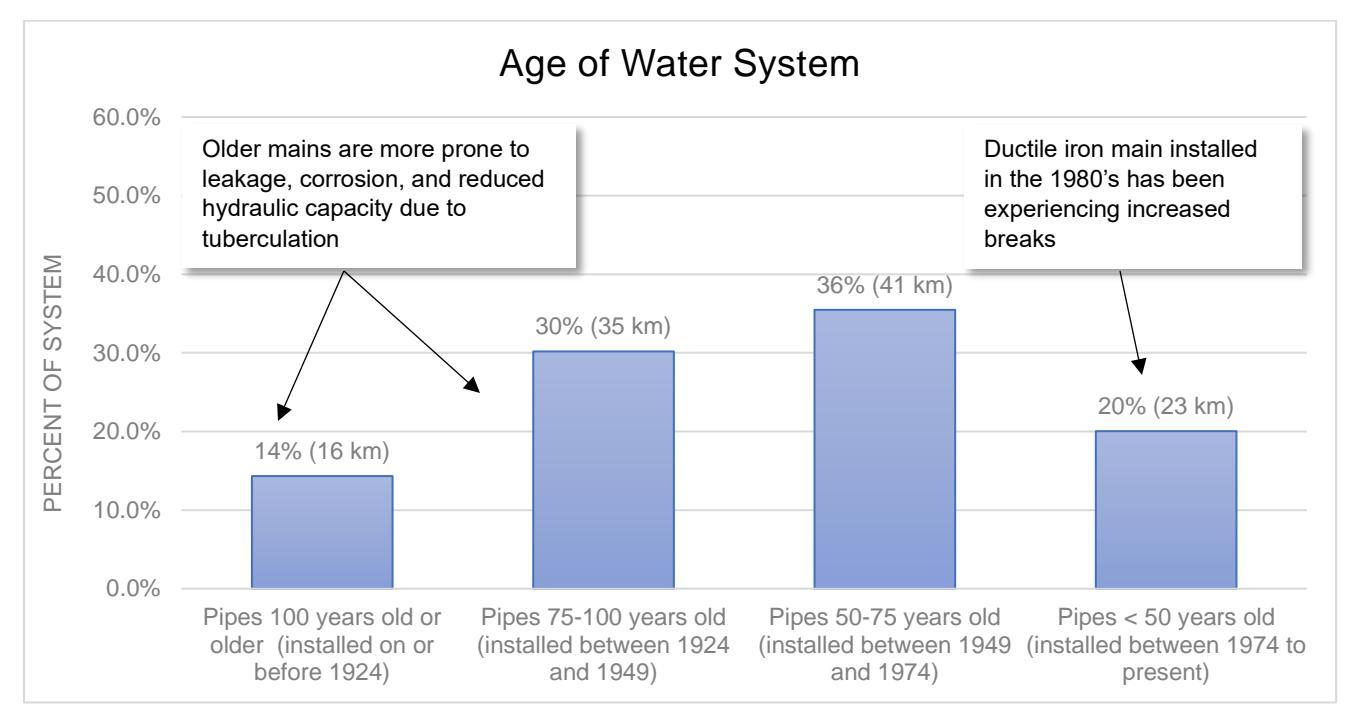
Figures 1 to 3 illustrate the main age, material composition, and size of mains within the District's water system. Percentages are approximate and are rounded.

Based on Figures 1 to 3, Staff have determined that the percentage of the system that is considered **high priority is in the range of 40%** when accounting for age, material, and size of mains and removing any overlapping characteristics (ex. asbestos cement mains greater than 100 mm). Replacement using conventional or trenchless technologies is recommended where possible.

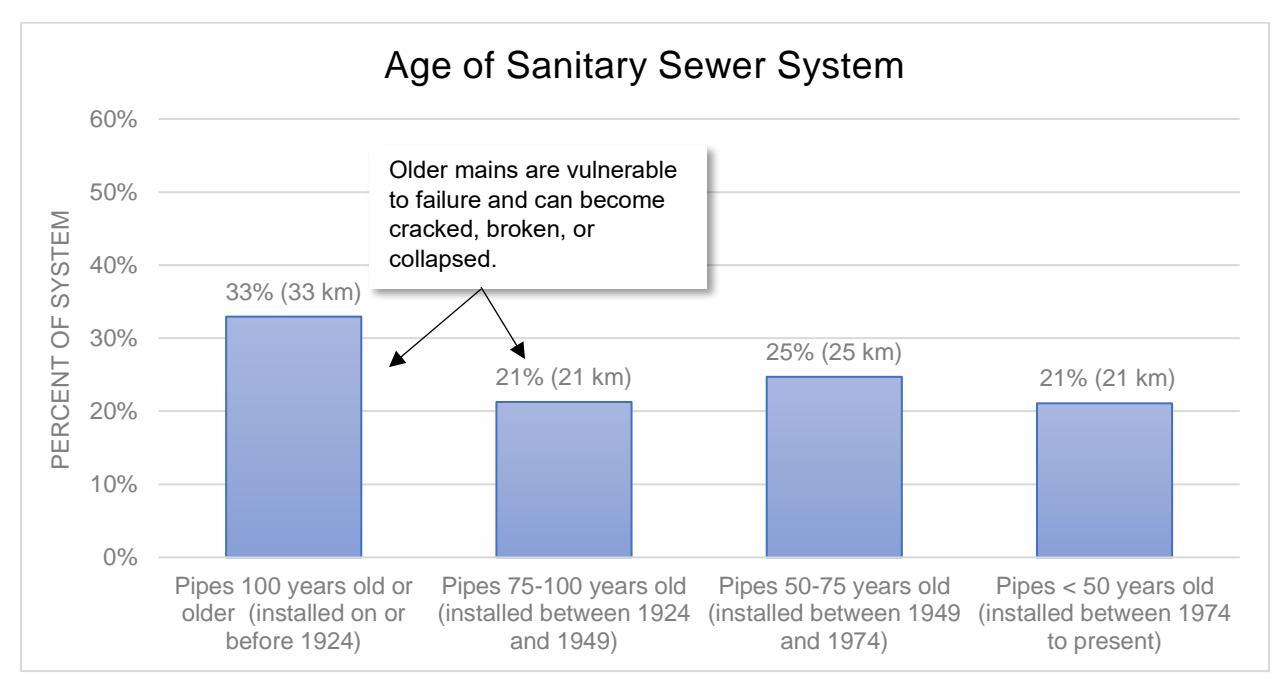
Figure 4: Sanitary Sewer System Age

Based on Figures 4 to 6, Staff have determined that the percentage of the system that is considered **high priority is in the range of 70%** when accounting for age, material, and size of mains and removing any overlapping characteristics (ex. asbestos cement mains greater than 150 mm). Replacement using conventional or trenchless technologies is recommended where possible.

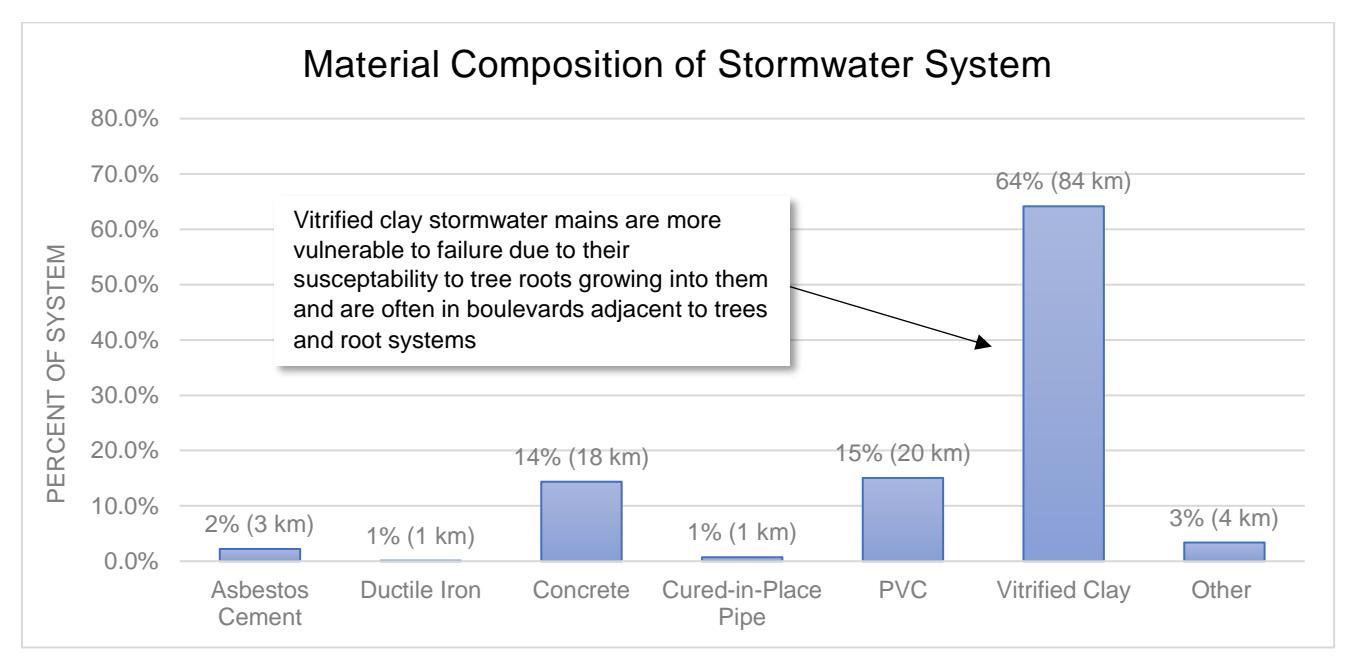
Figure 8: Stormwater System Material

Based on Figures 7 to 9, Staff have determined that the percentage of the system that is considered **high priority is in the range of 40%** when accounting for age, material, and size of mains and removing any overlapping characteristics. Replacement using conventional or trenchless technologies is recommended.

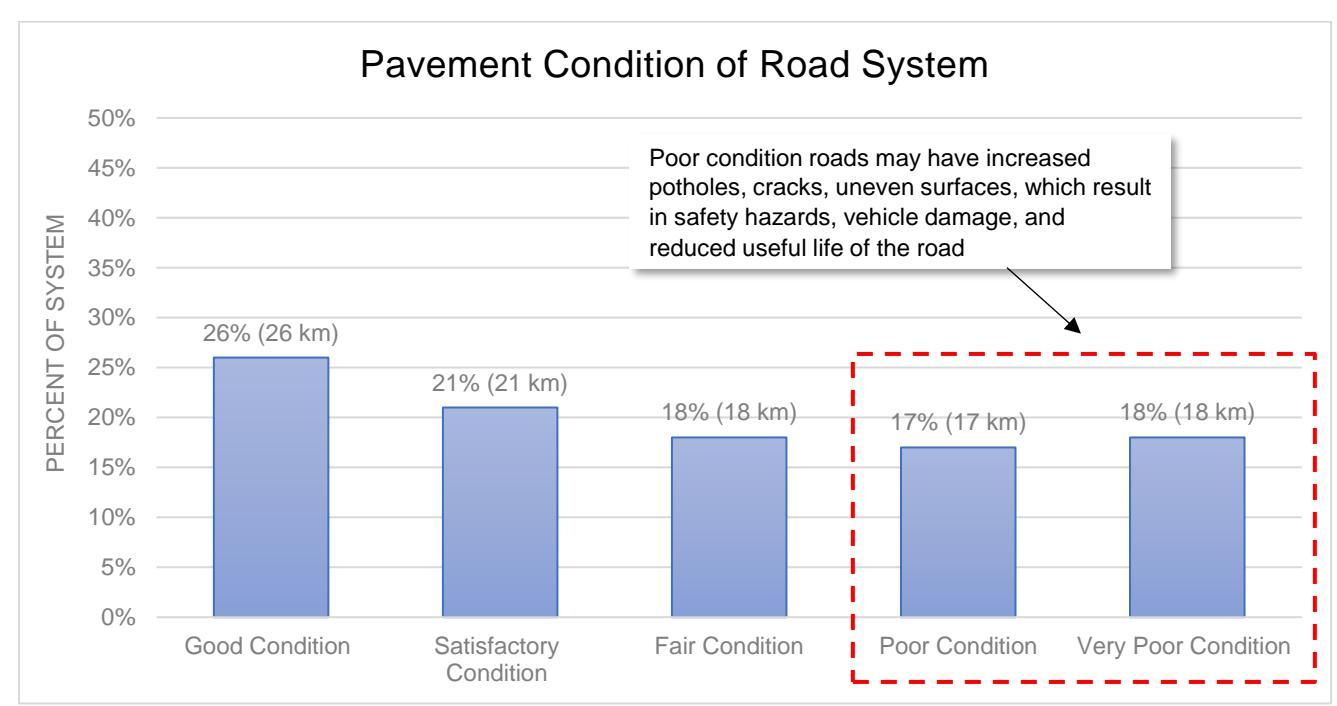
Figure 10: Pavement Condition Distribution in Terms of Pavement Condition Index (PCI)

Based on Figure 10, approximately **35% of the road infrastructure is in poor or very poor condition**. If left too long, the road base, rather than just the asphalt layer typically needs to be excavated to repair – this adds significant cost. Staff recommend that a proactive approach be taken and to perform preventative maintenance programs such as crack sealing, early pothole repair with larger patches, etc., where feasible.

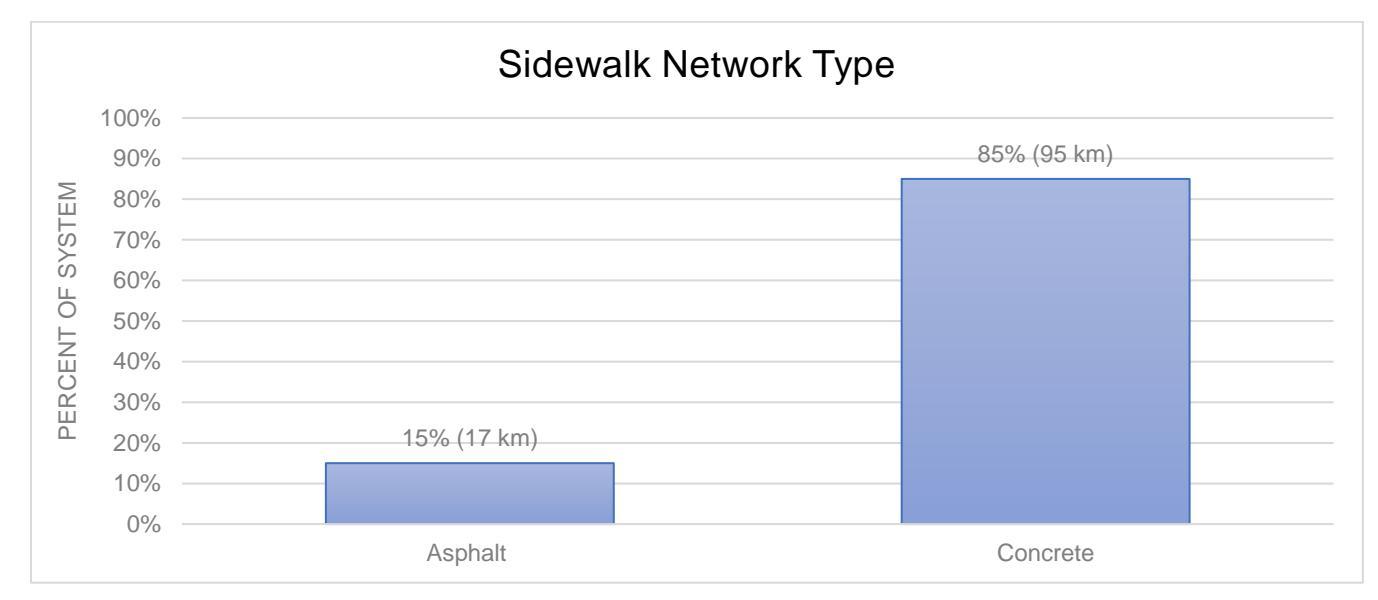
Figure 11: Sidewalk Network Type

- No prioritization of asphalt vs concrete sidewalk type replacement based on trip hazard, severity, accessibility concerns, etc.
- Based on the Sidewalk Condition Index (SCI) which expresses the condition of the sidewalk as a function of the severity and extent of the visible surface distresses, the sidewalk network <u>received an overall score of 76</u> (based on a score of 0-100) with 0 being the worst and 100 being the best.

- Slab replacement is recommended to maintain the sidewalk network. Patching, crack repair, and grinding are recommended maintenance activities to make safe until slab replacement can take place.

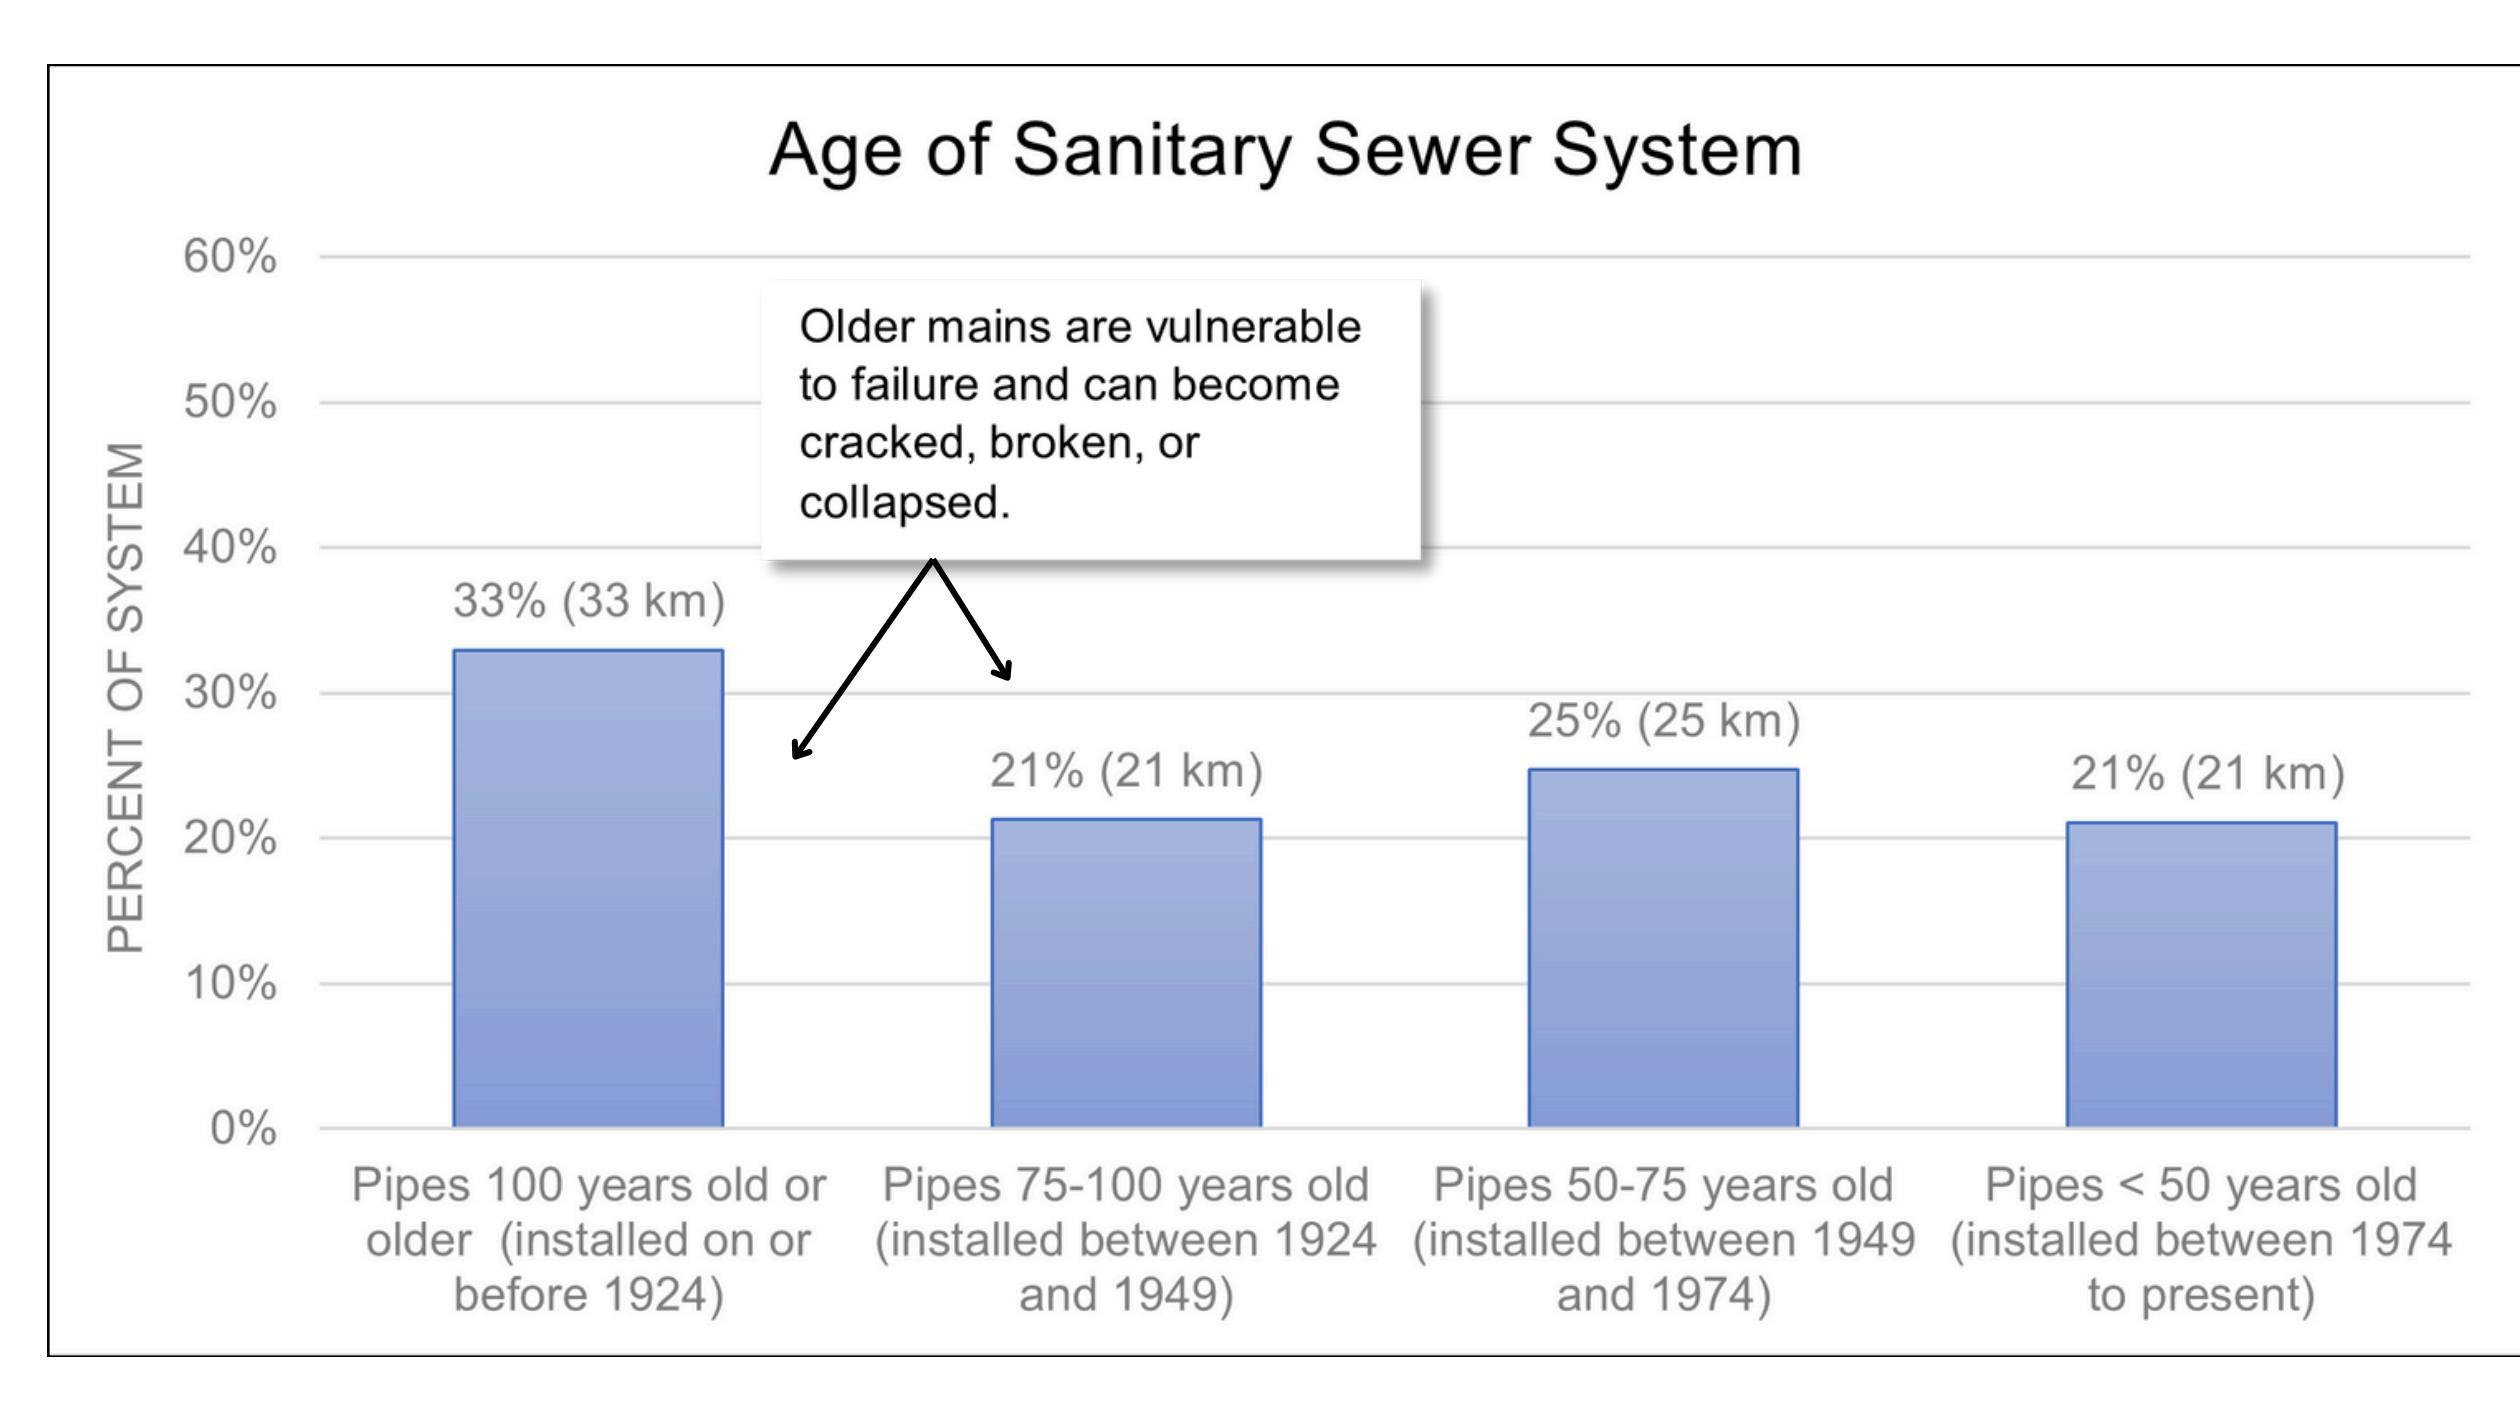
AGE OF THE SANITARY SEWER SYSTEM

The average age of the sanitary sewer system is **75 years old.**

Typical useful life of a sewer main is 40 to 100

years

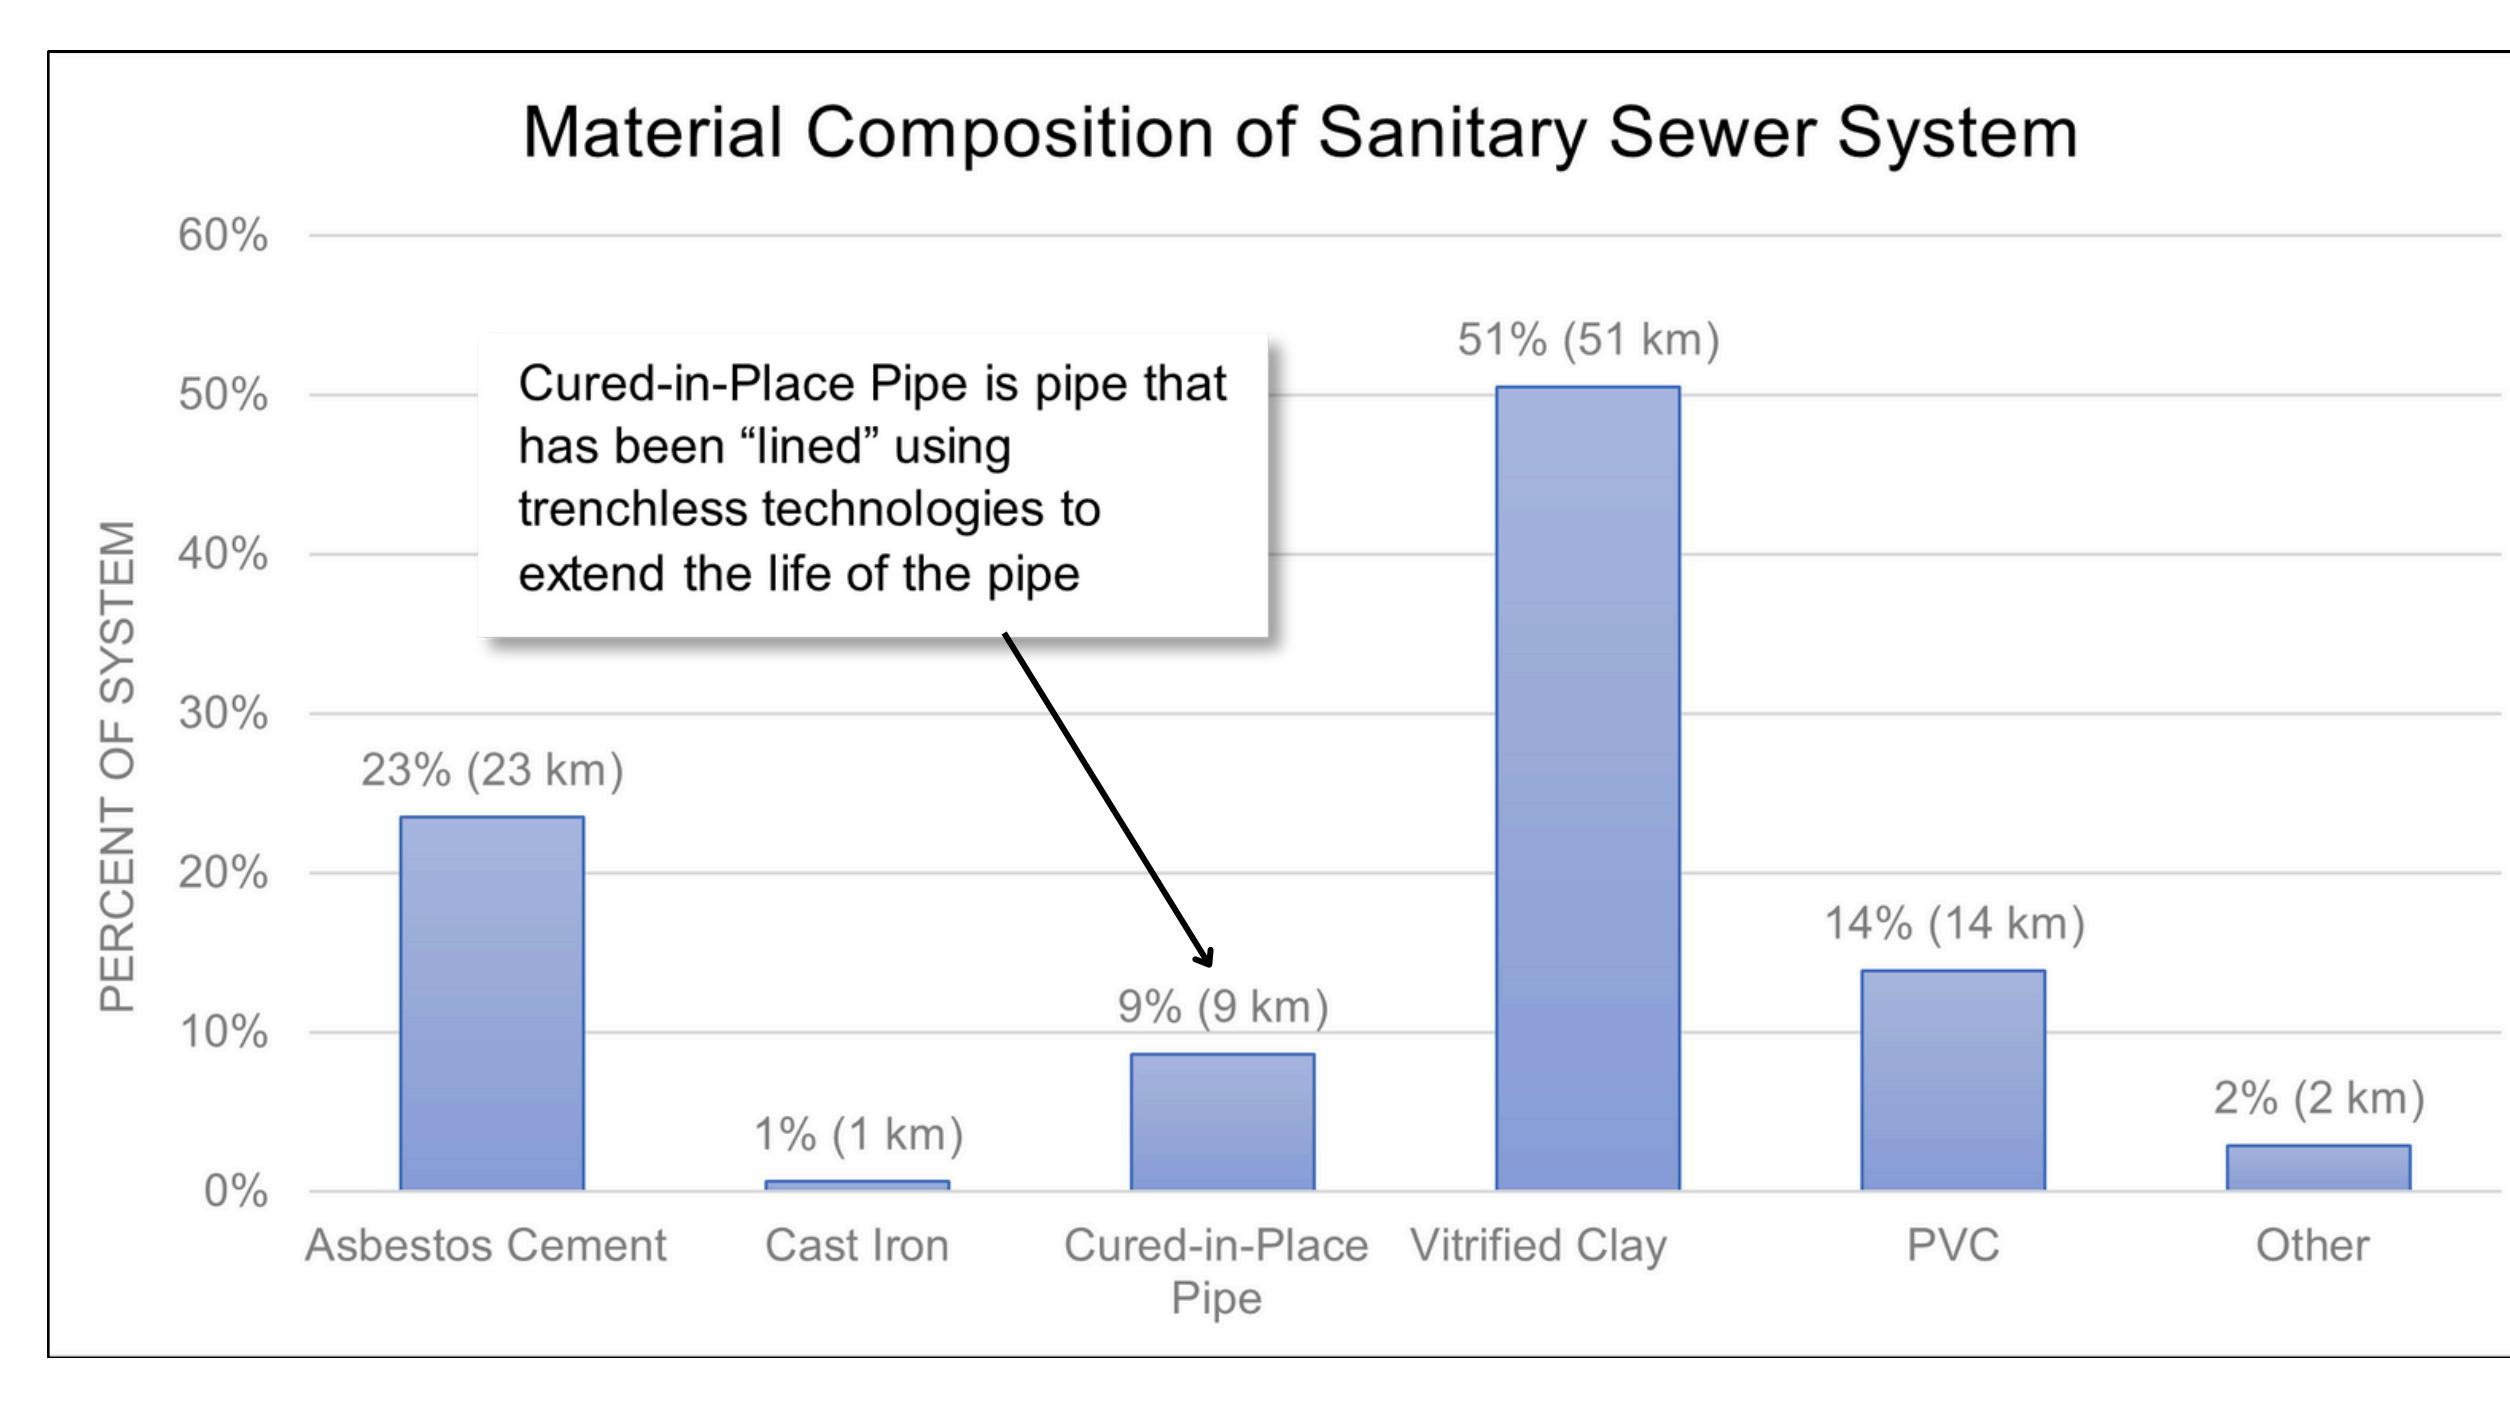
MATERIAL COMPOSITION OF THE SANITARY SEWER SYSTEM

The District's sanitary sewer system primarily consists of **vitrified clay, asbestos cement, and PVC.**

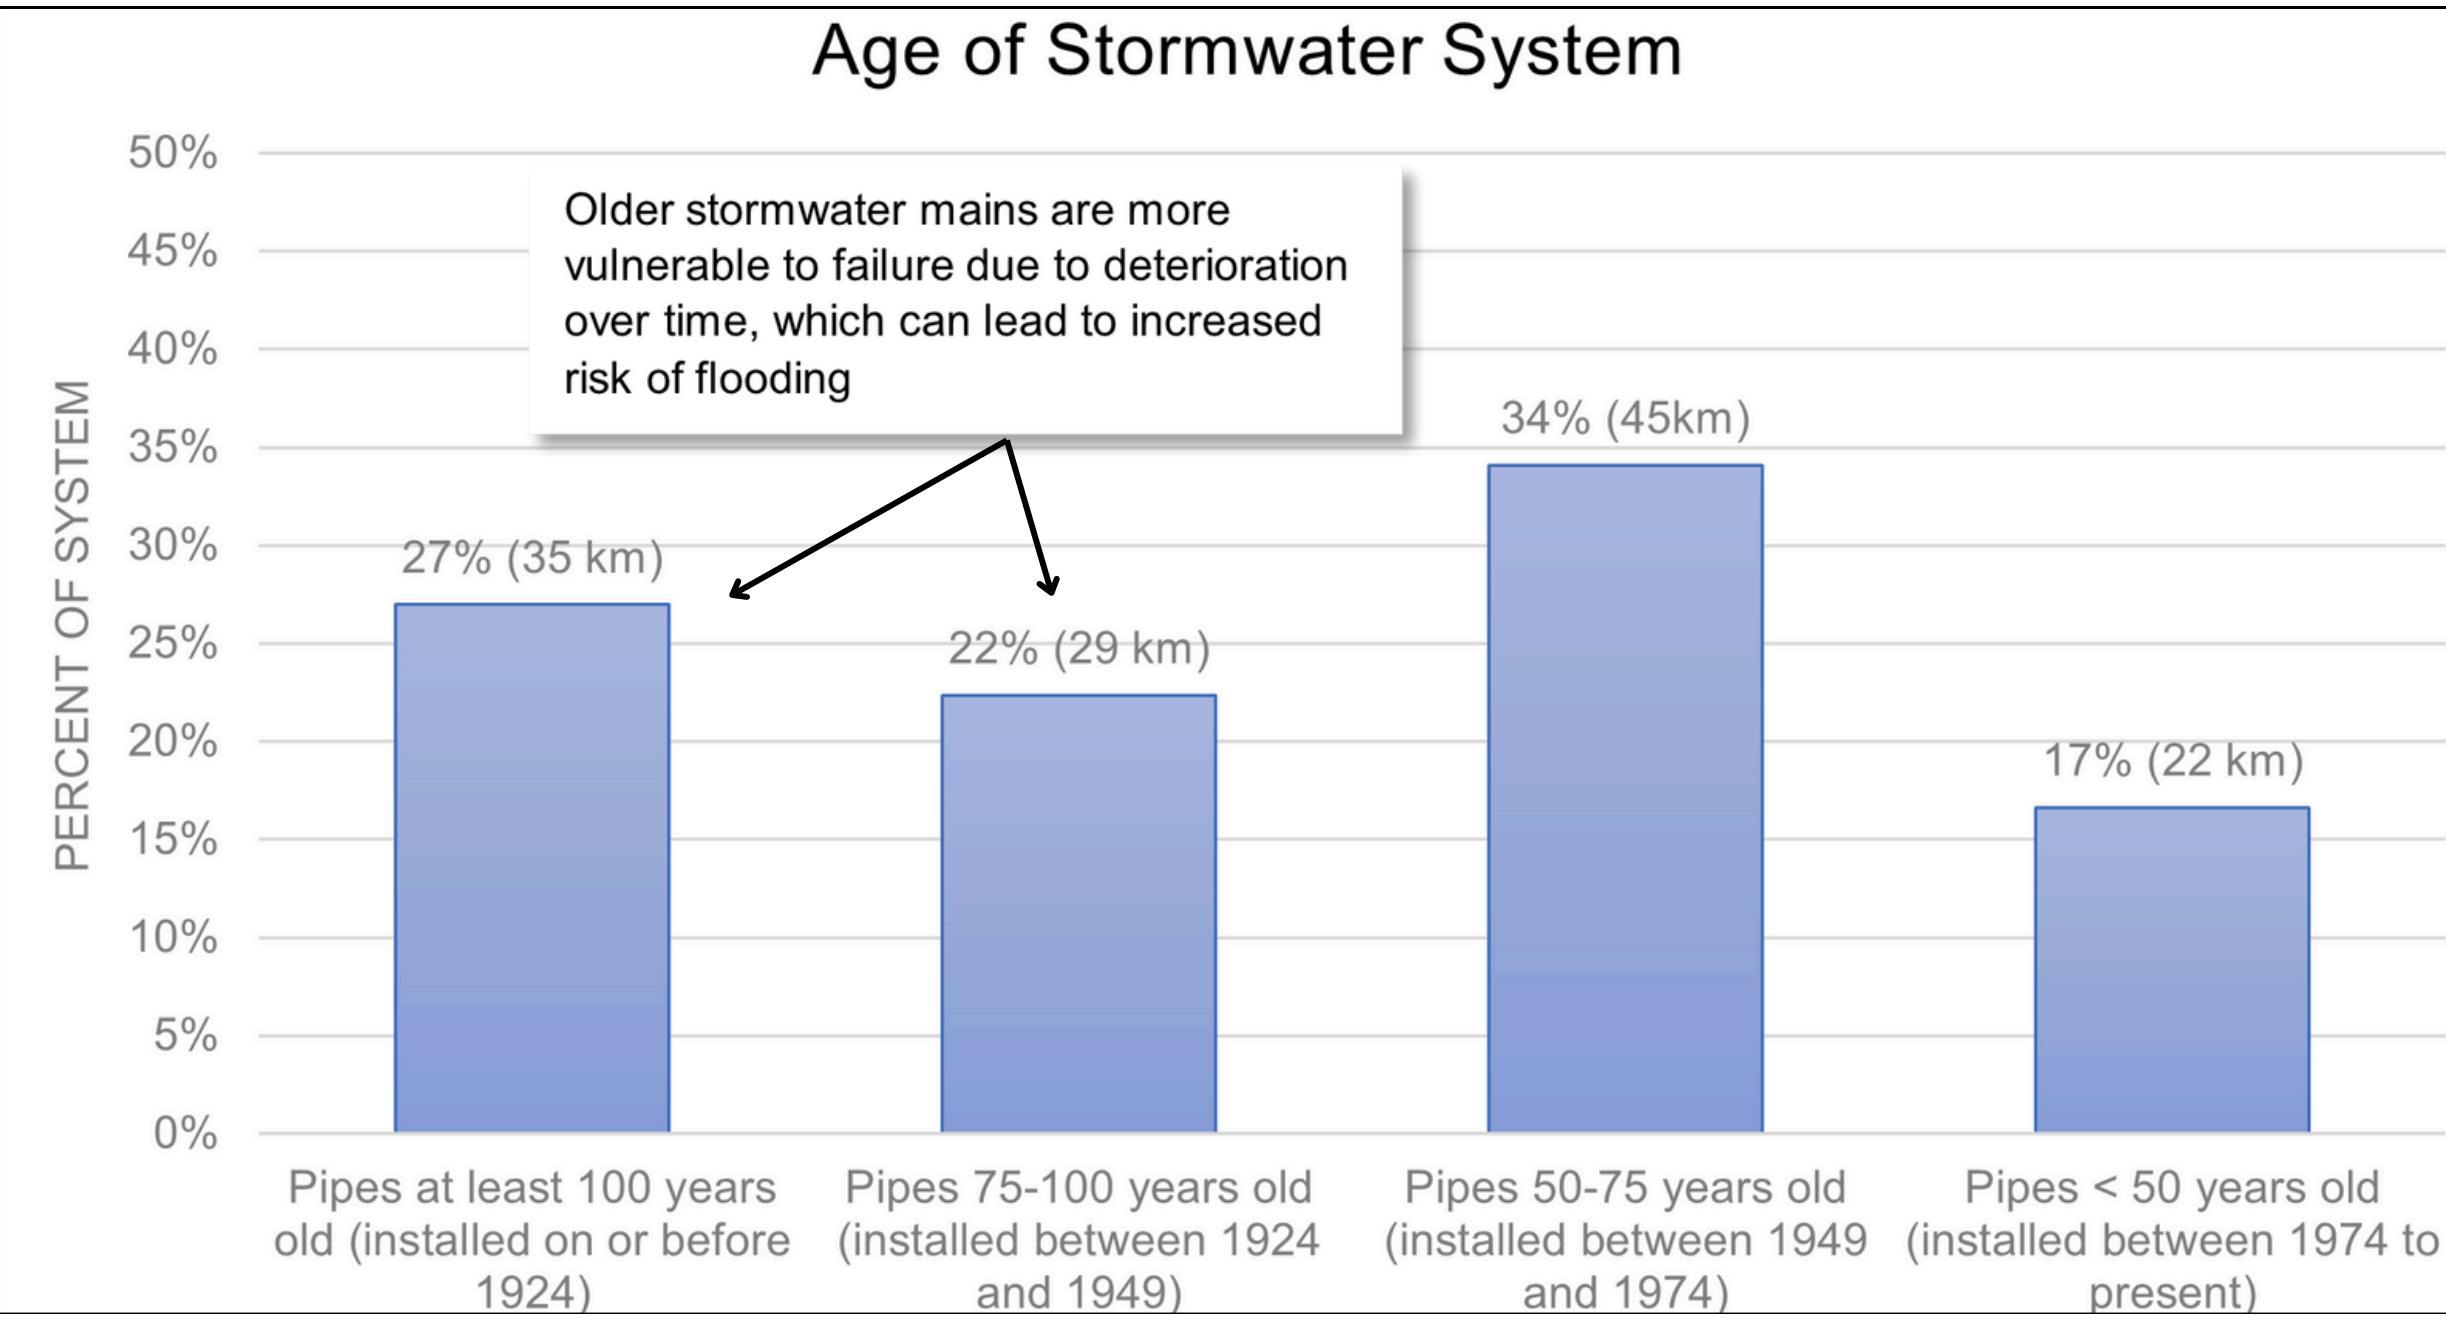
AGE OF THE STORMWATER SYSTEM

The average age of the stormwater system is **72 years** old.

Typical useful life of a stormwater main is 50 to

100 years

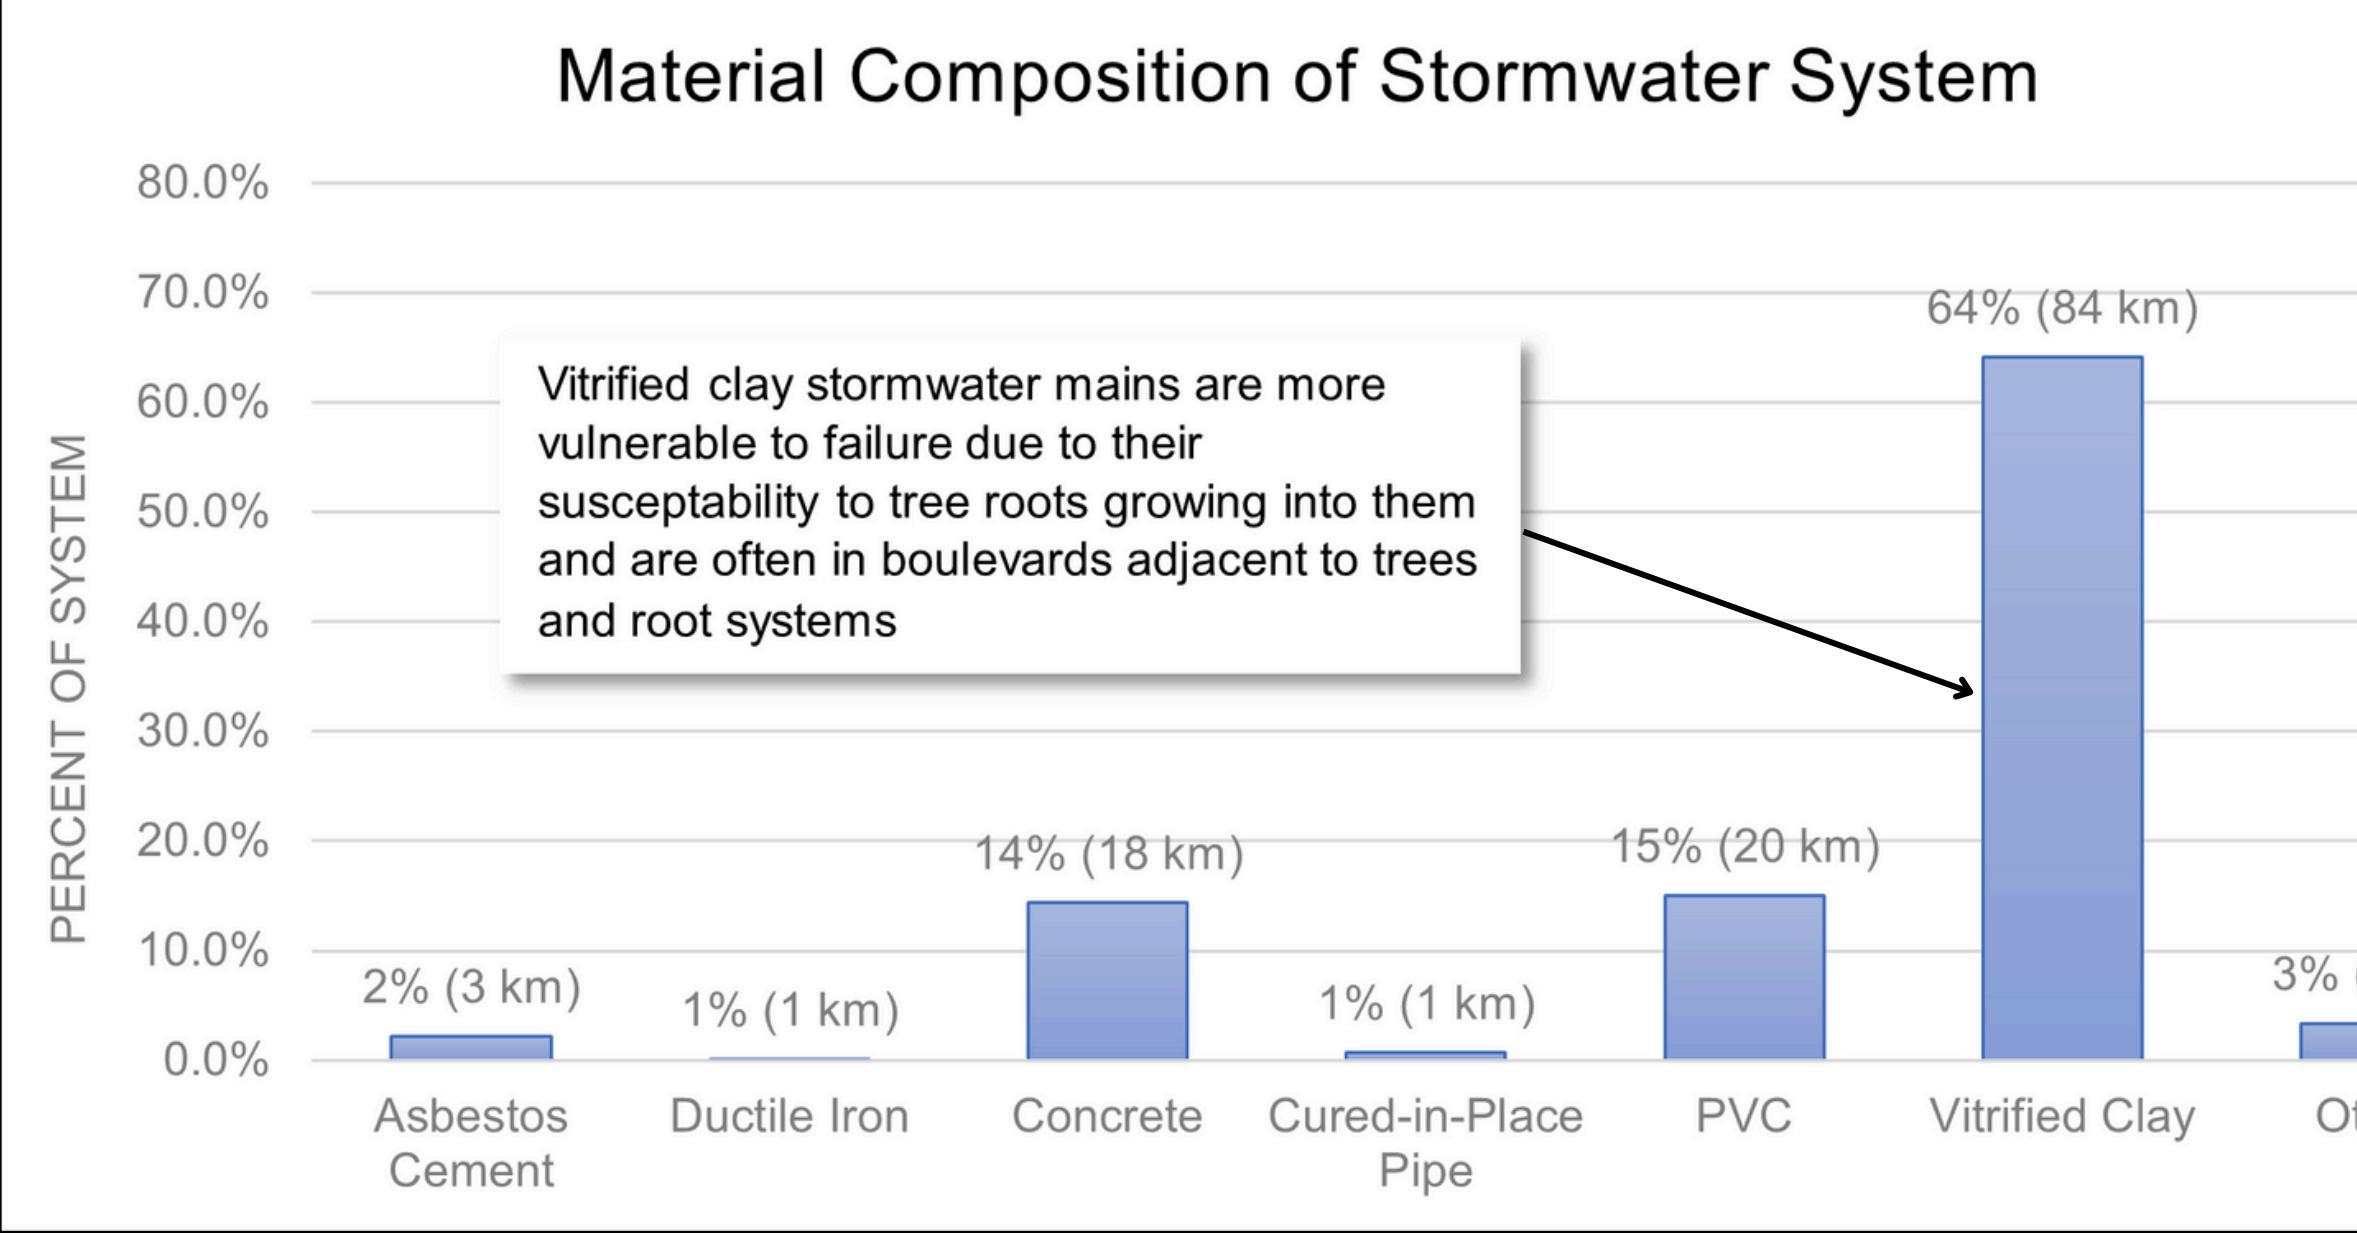
MATERIAL COMPOSITION OF THE STORMWATER SYSTEM

The District's stormwater system primarily consists of **vitrified clay, PVC, and concrete.**

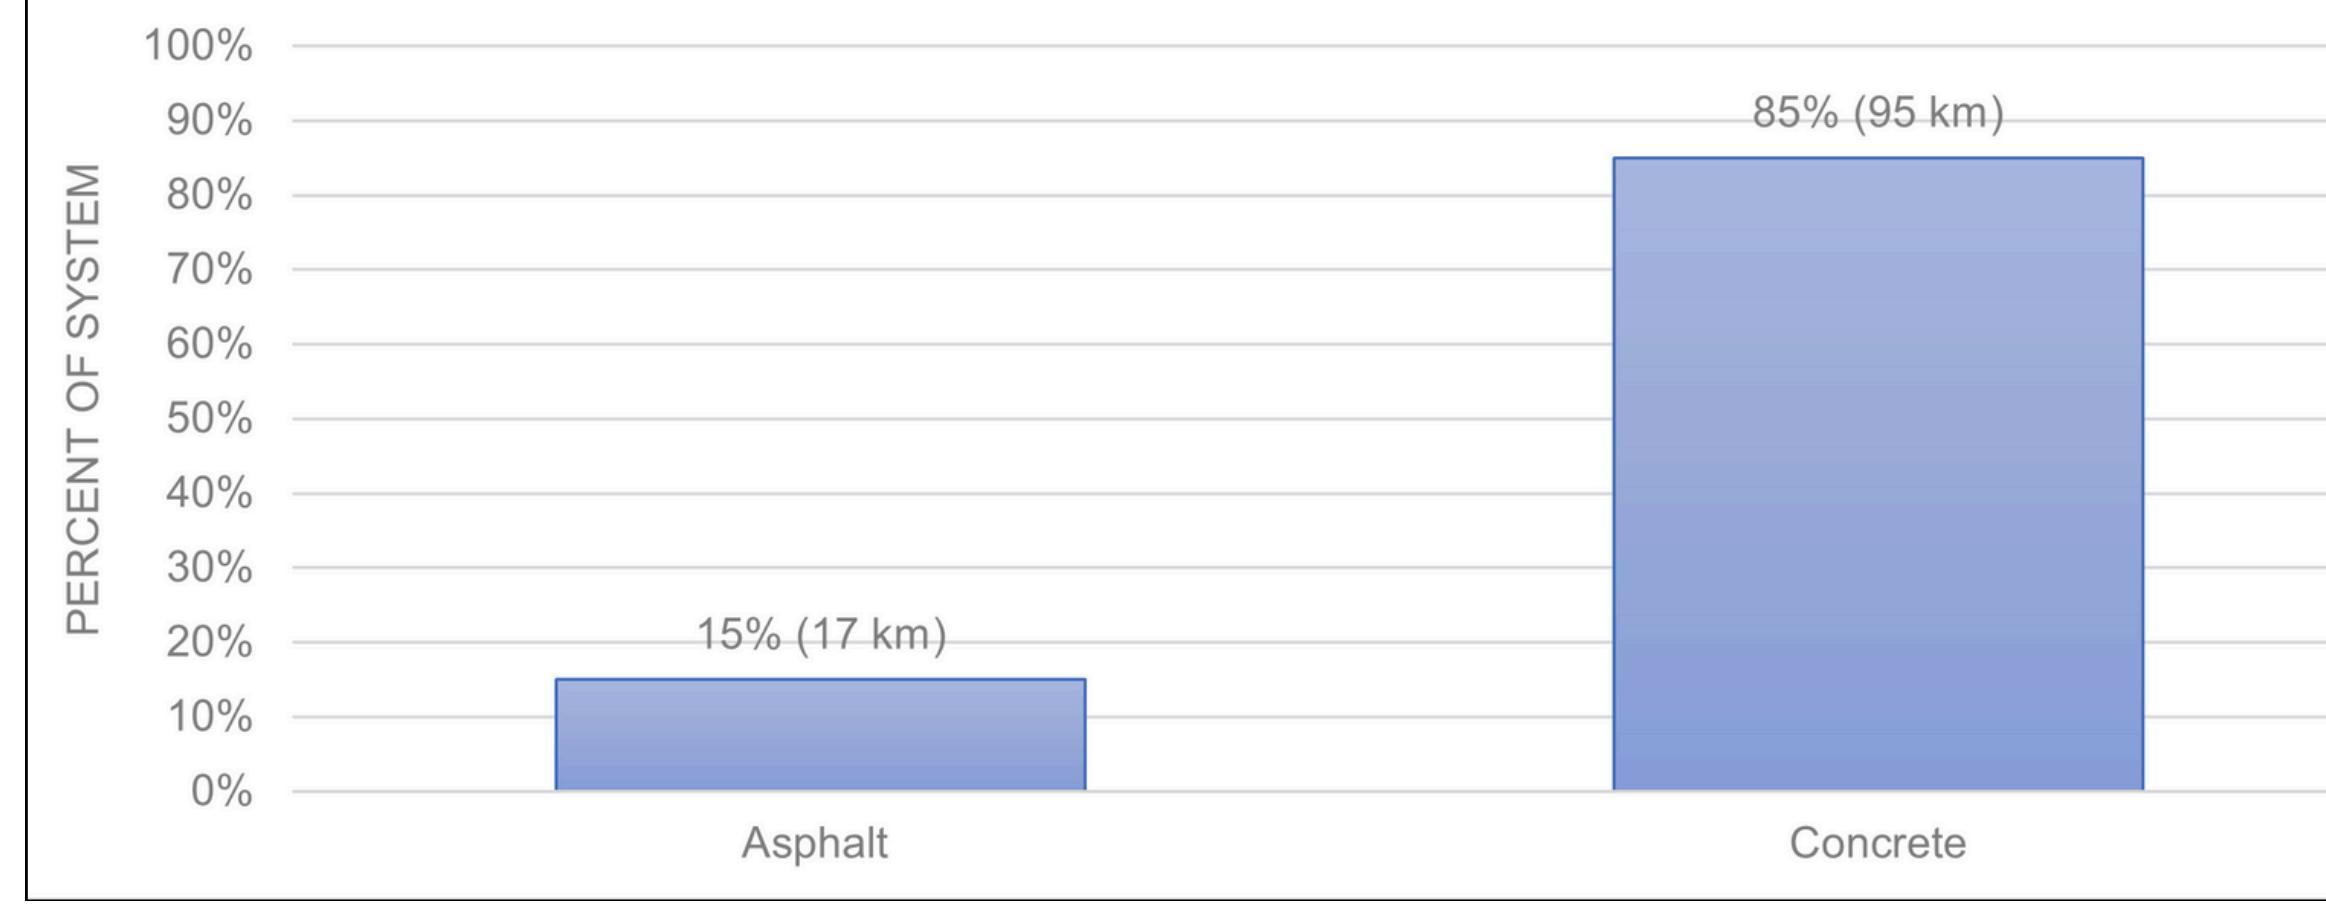
SURFACE INFRASTRUCTURE (SIDEWALKS)

The District has 112 km of sidewalk

Slab replacement is recommended to maintain network
